Landscape and adaptation

Doug Esagok and Chris Burn

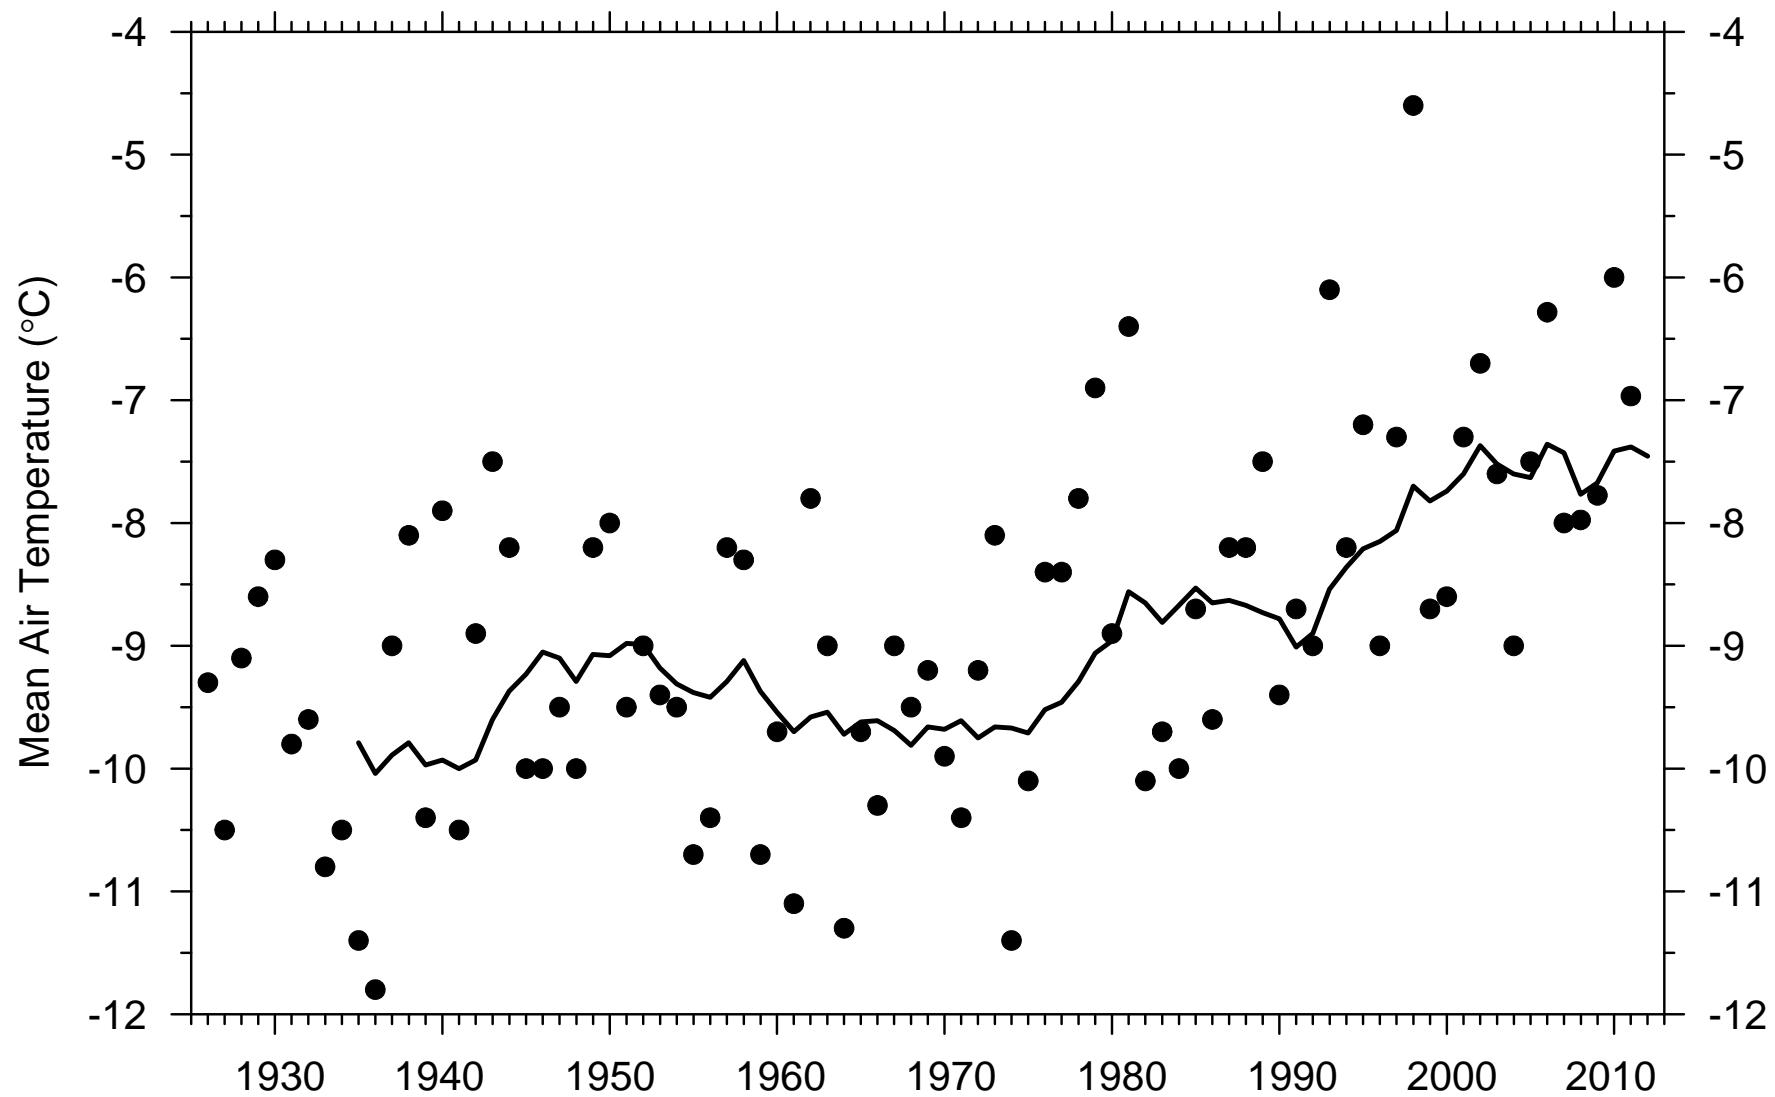
Delta air temperature, 1926-2012

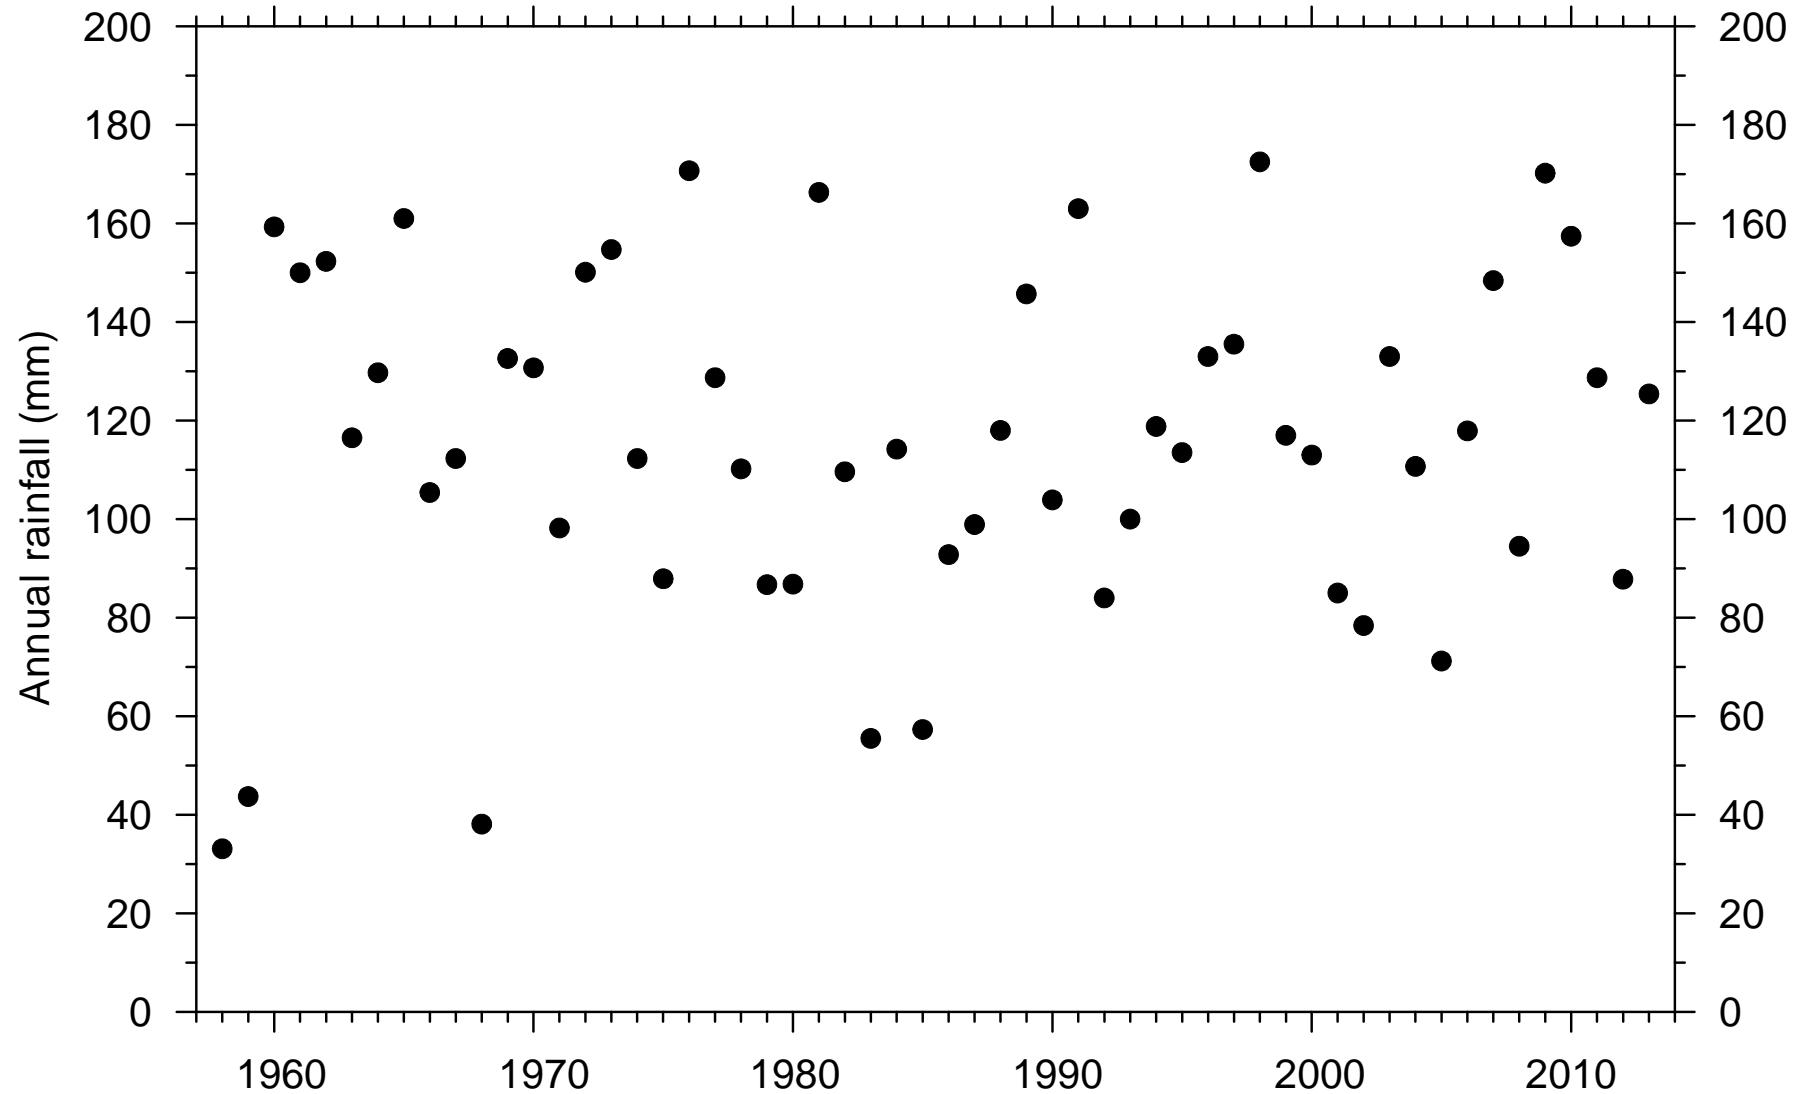
Inuvik rainfall, 1958-2013

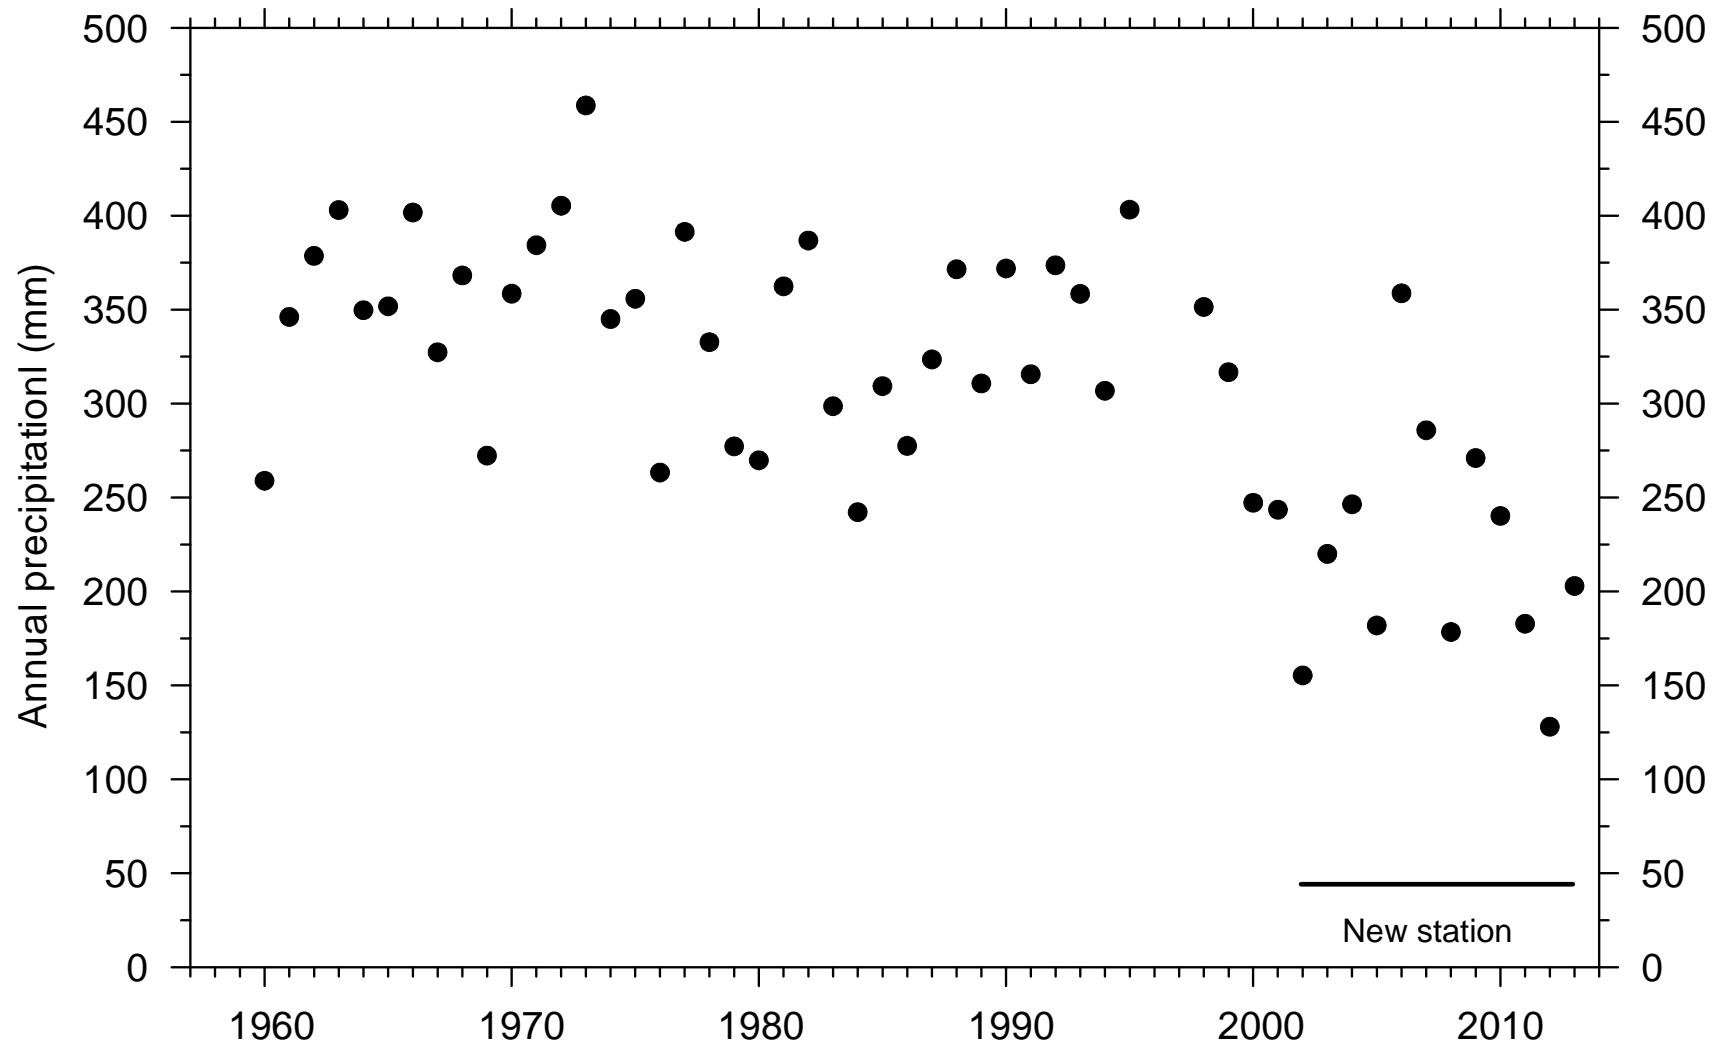
Total precipitation measured at Inuvik

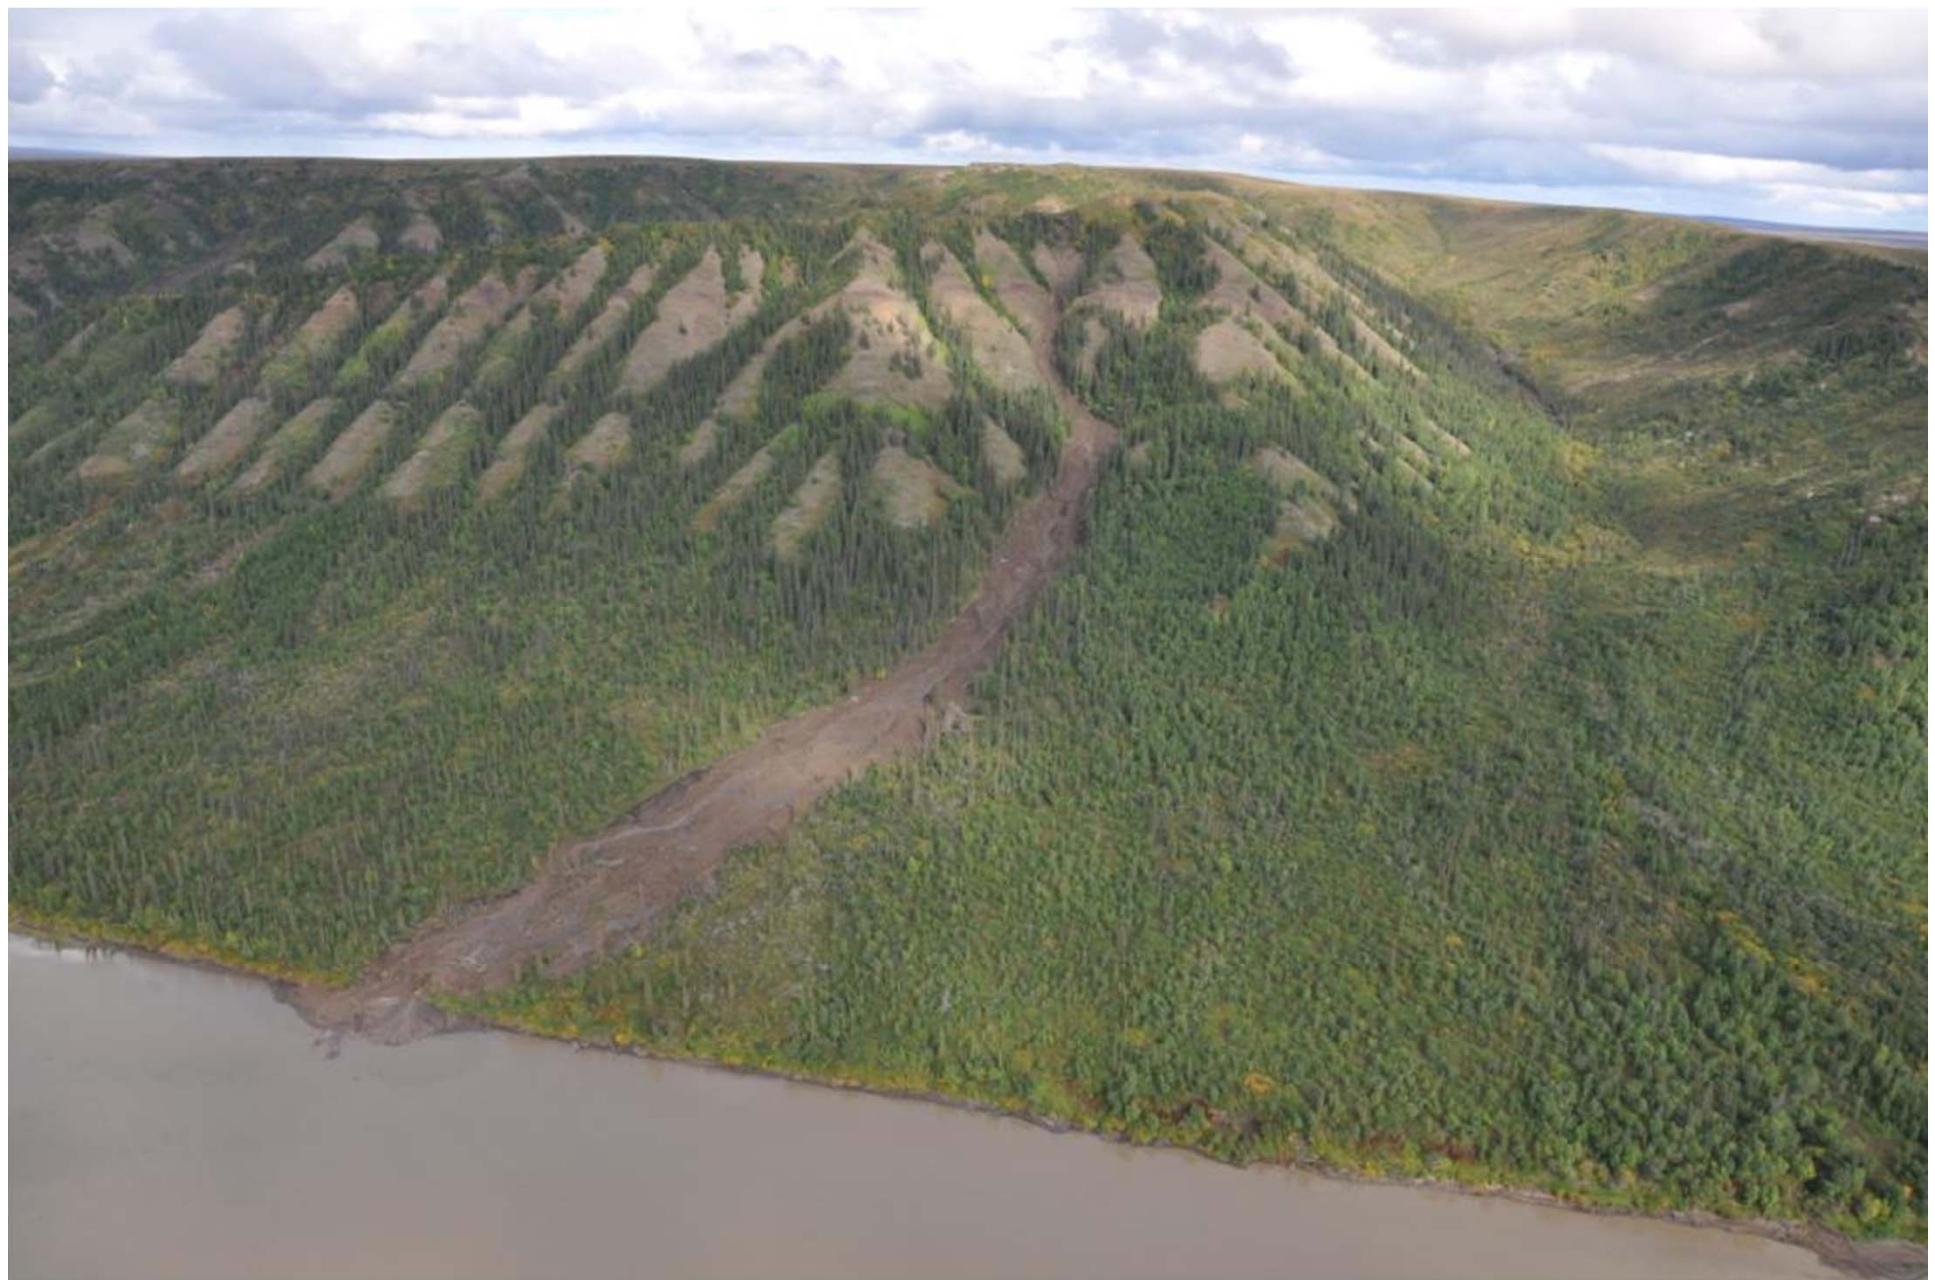
Landslides in the Caribou Hills, September 2009

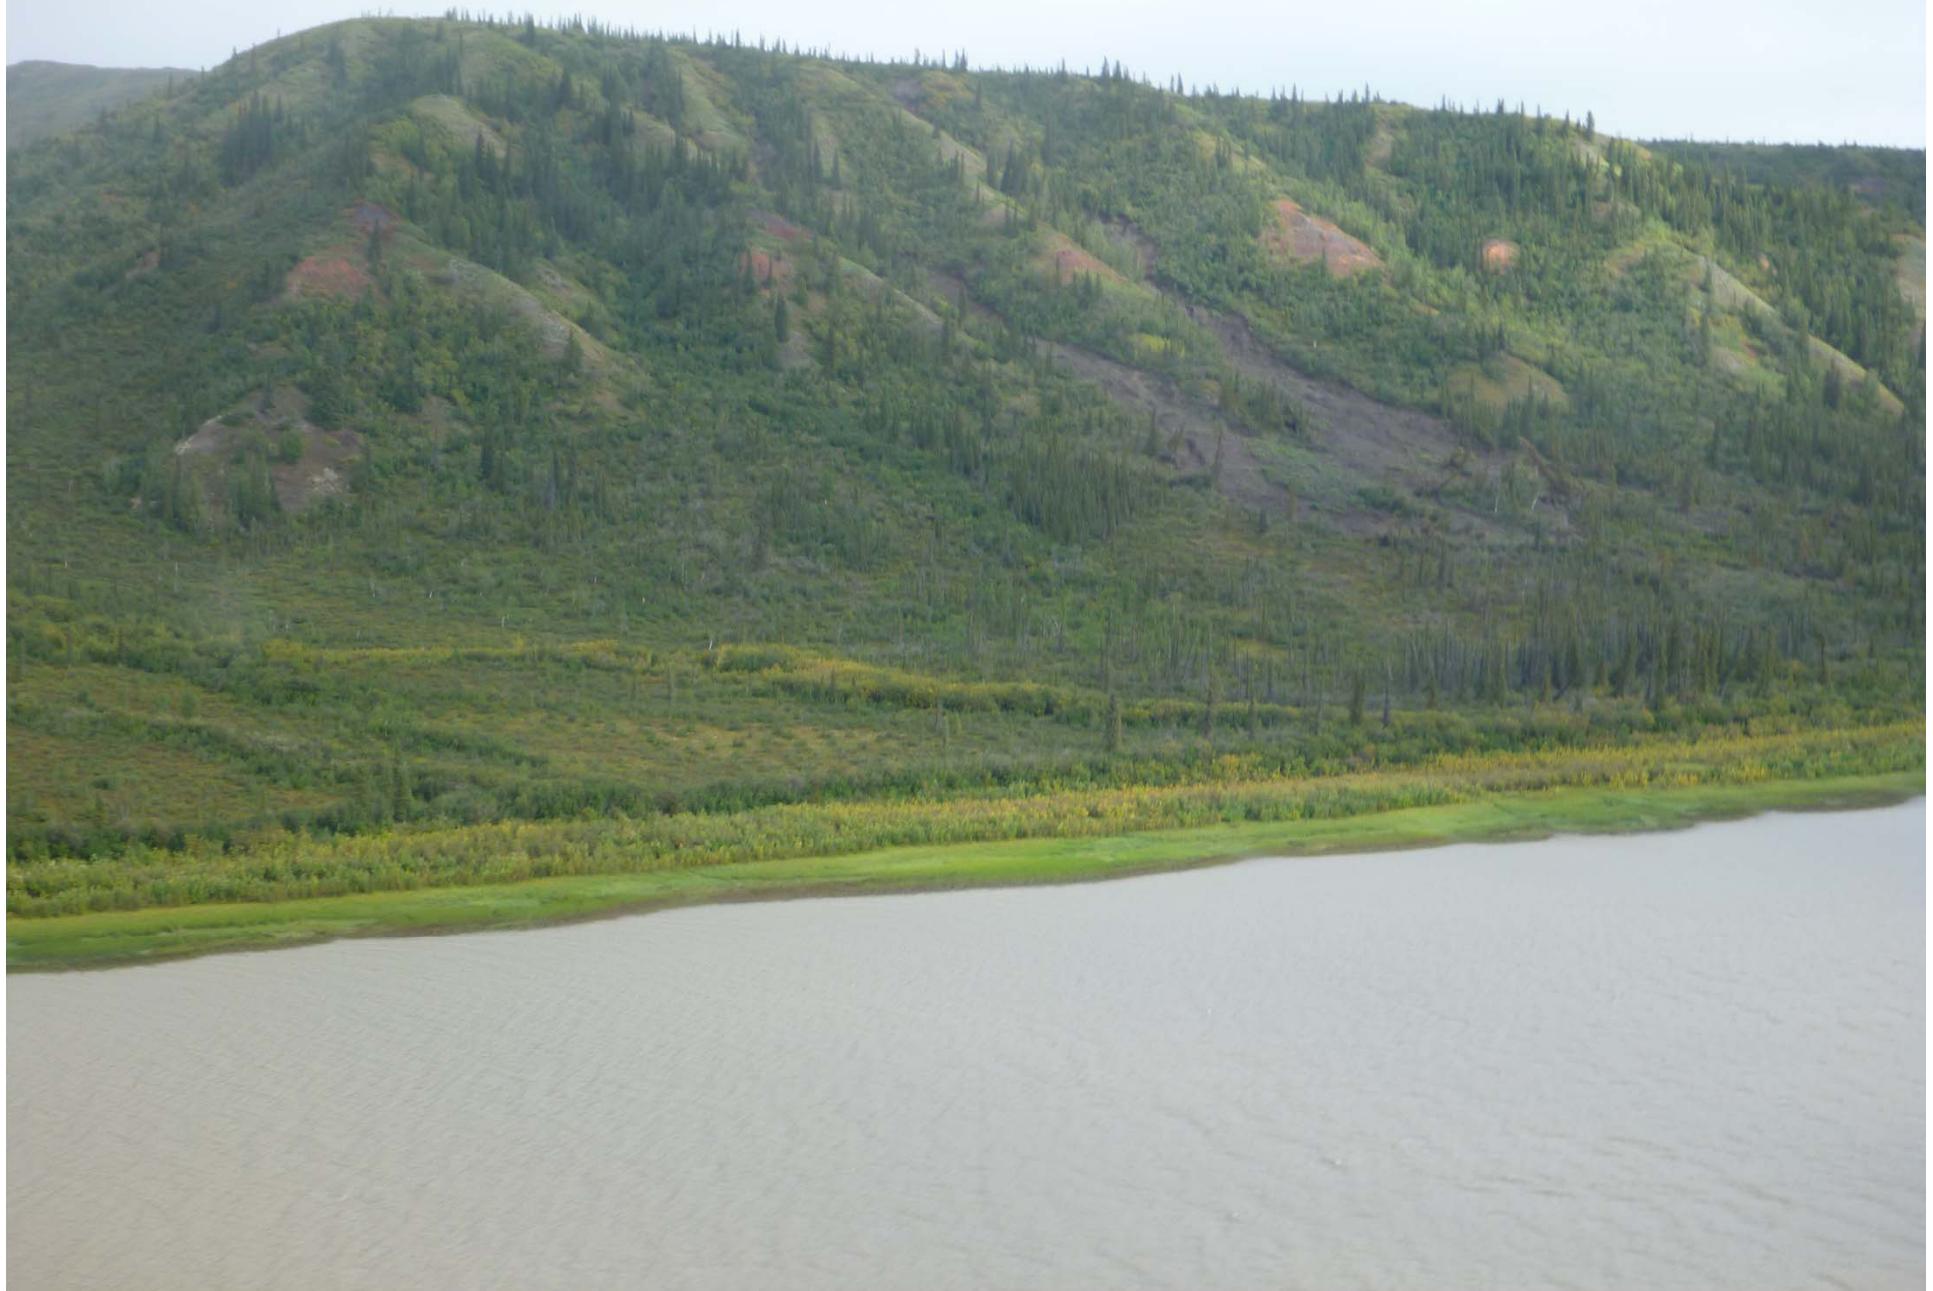
Mostly along East Channel

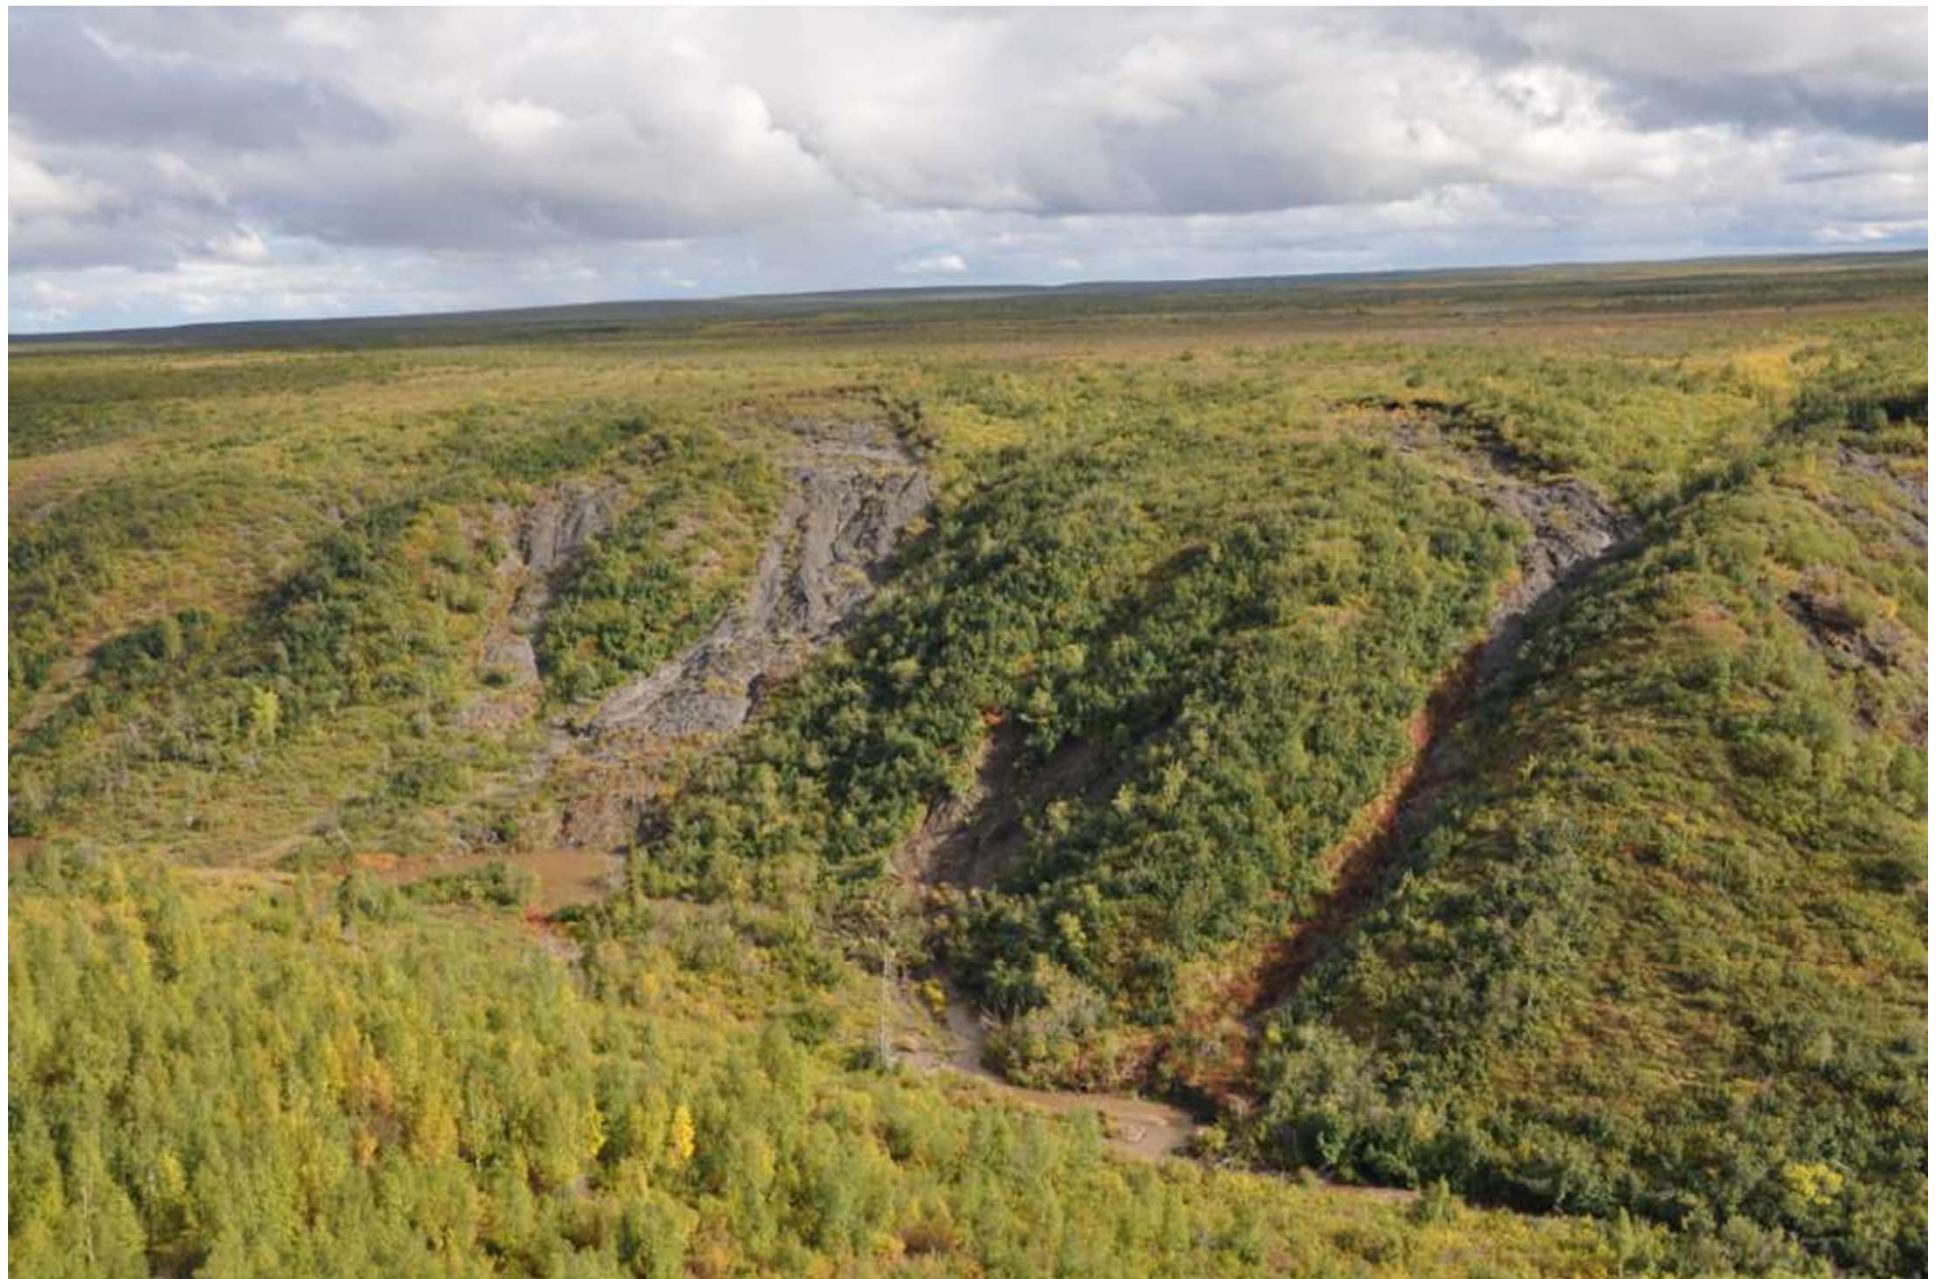
Over 25 distinct features

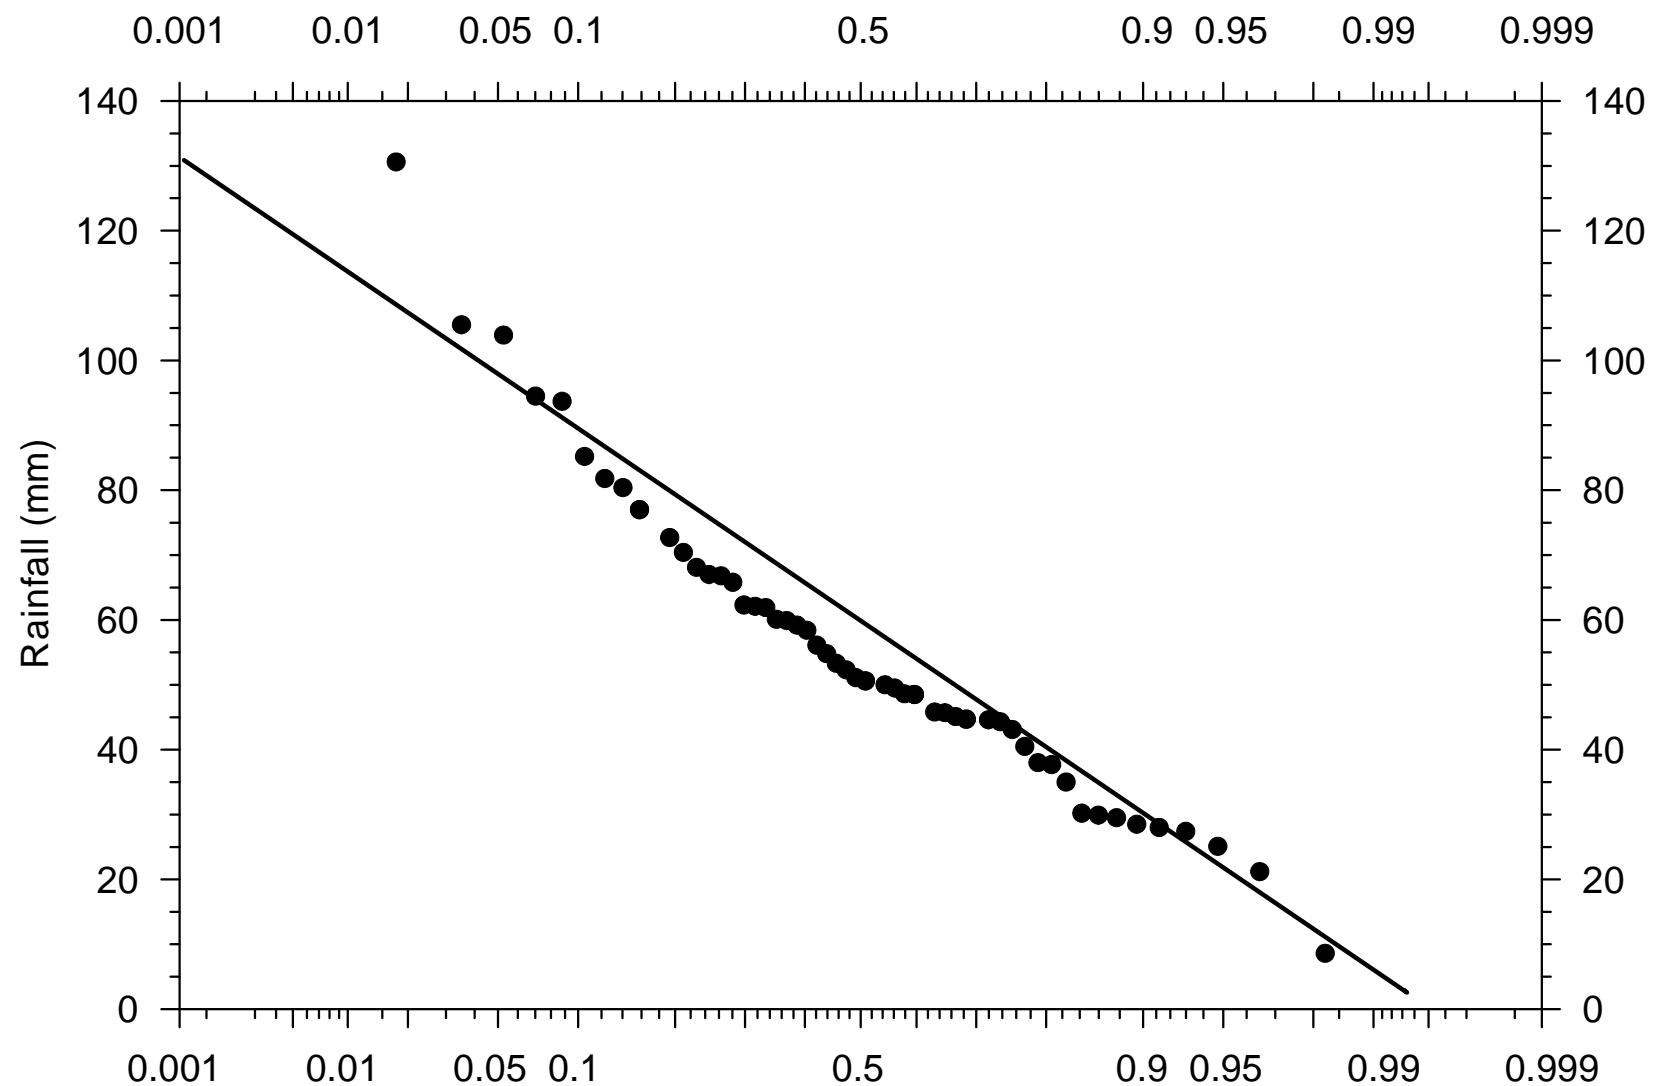
Excedence probability, Aug + Sept rainfall, 1958-2013

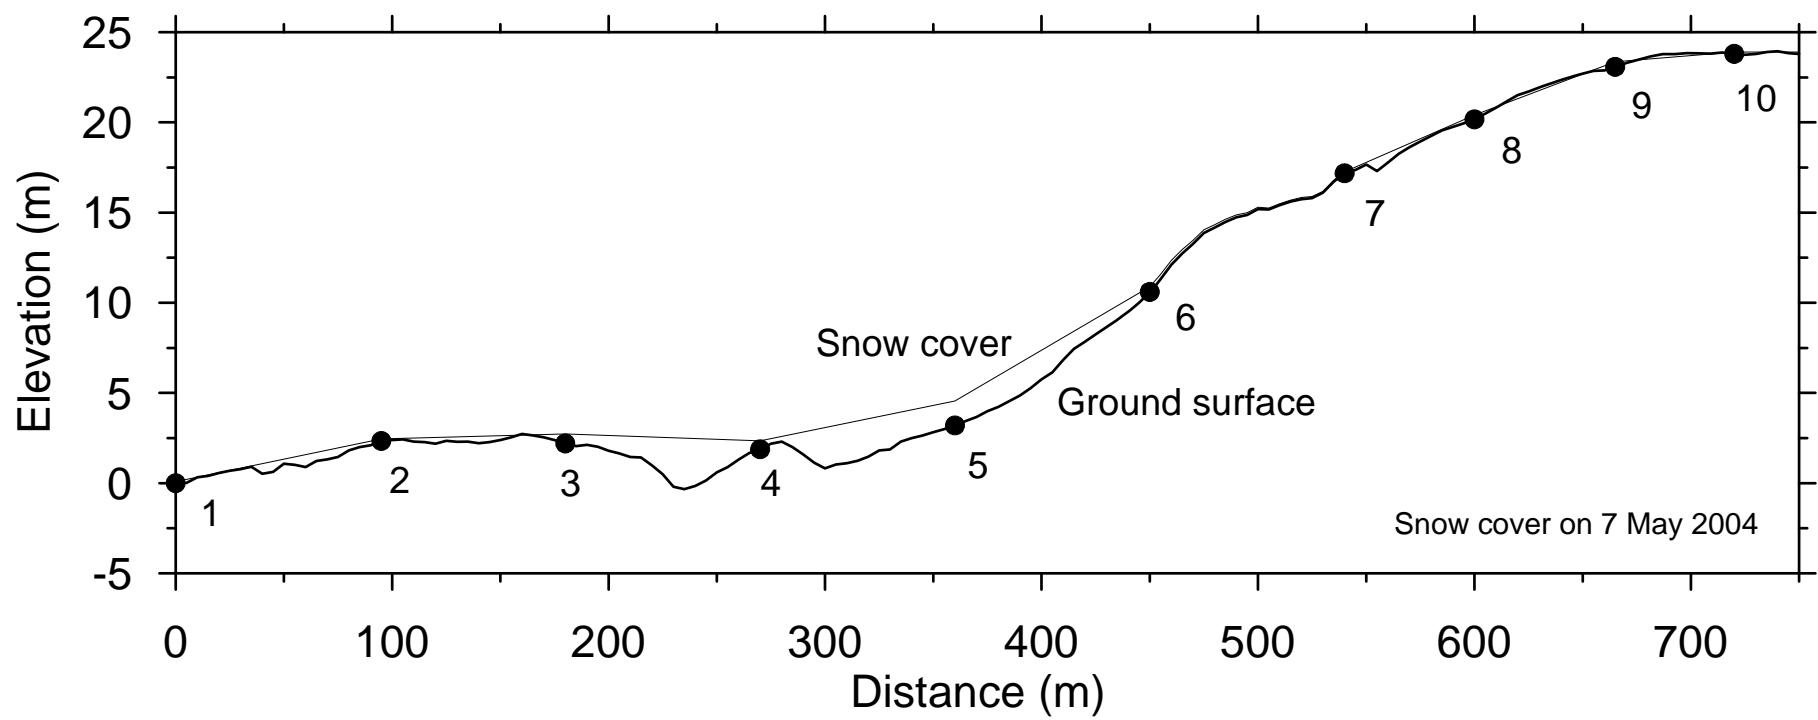
Hillslope profile at Collinson Head

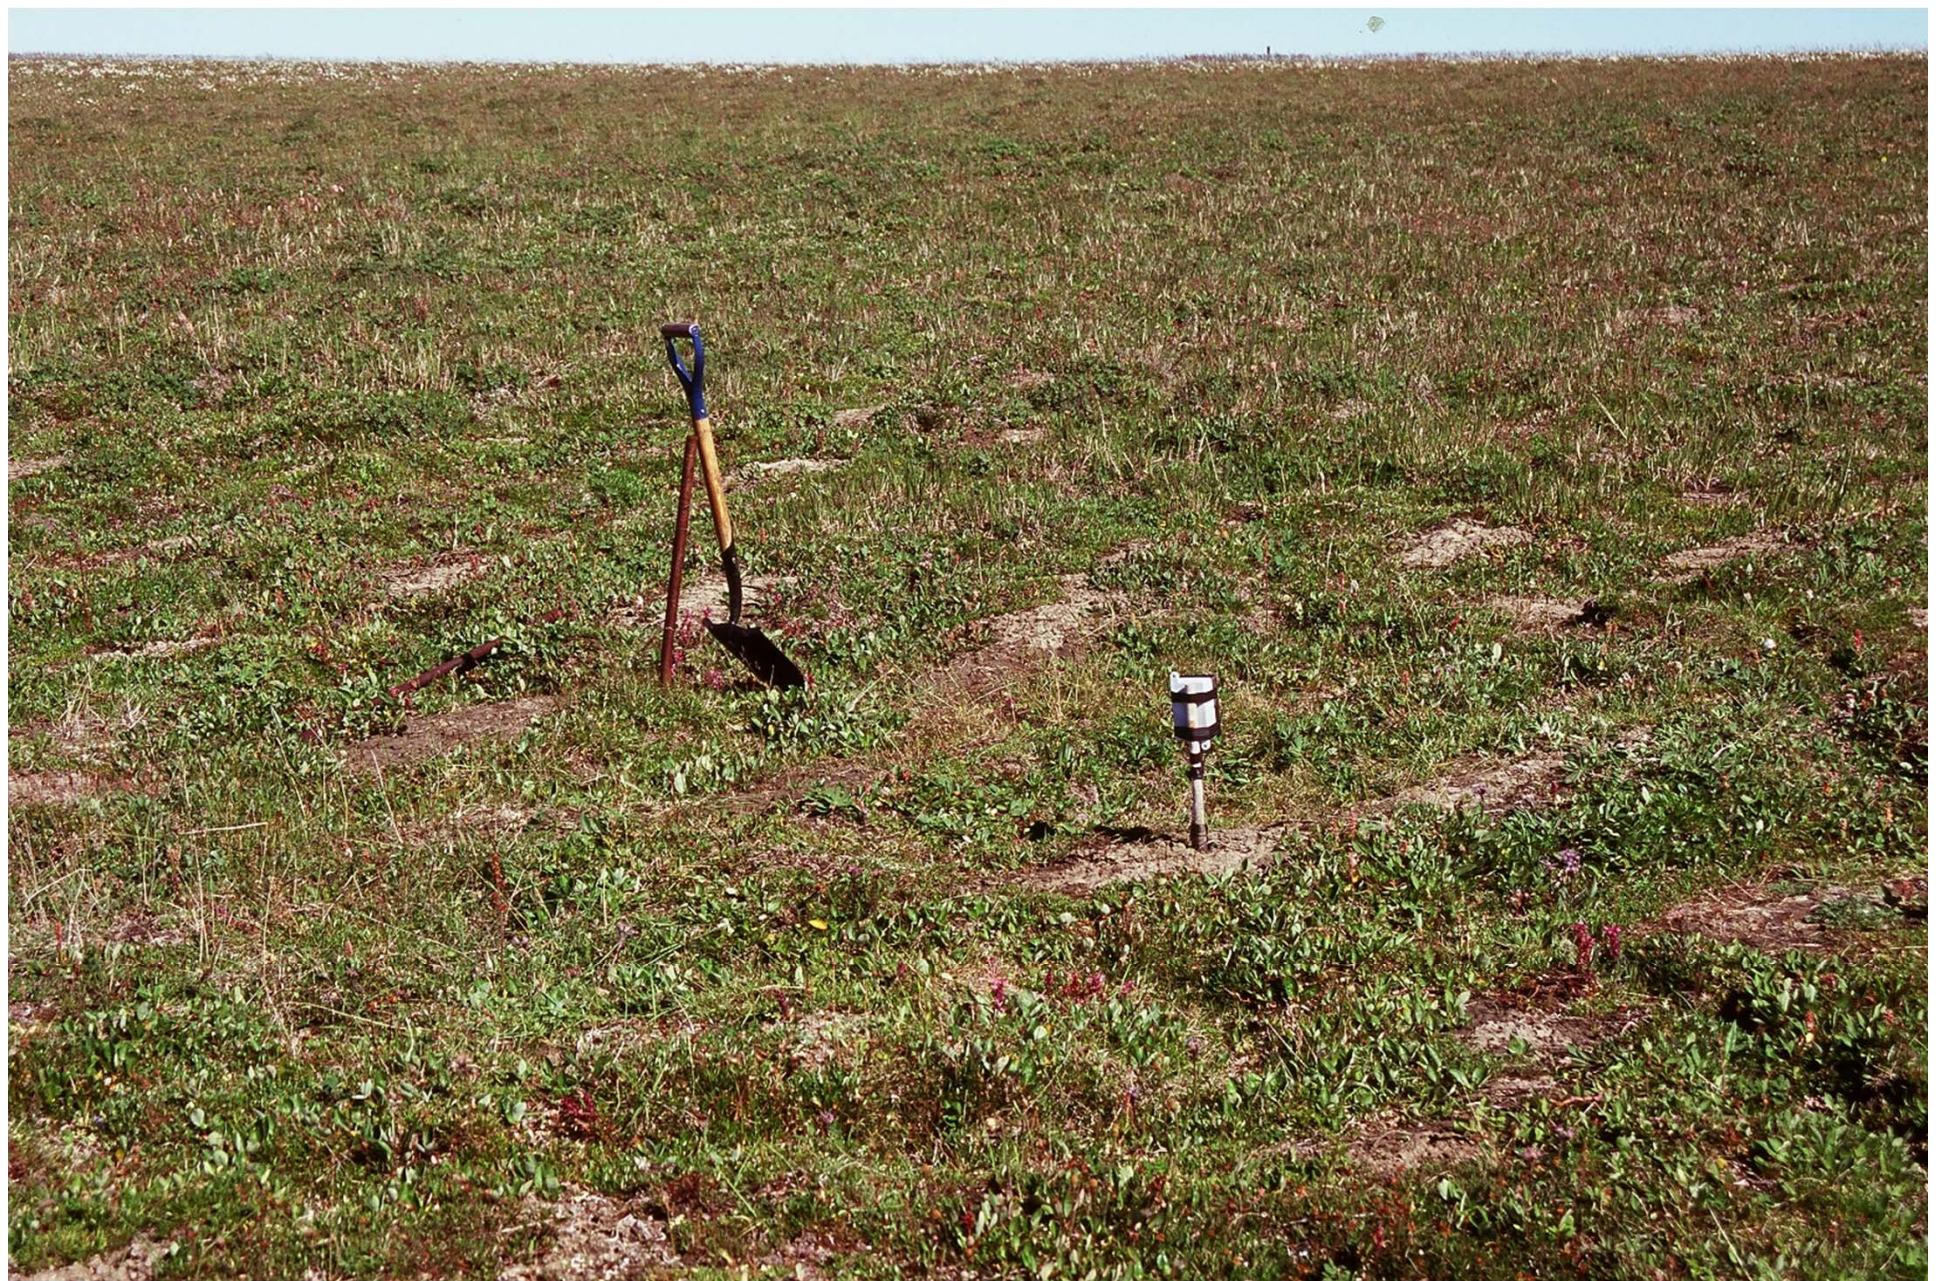
Mud hummocks at site 8

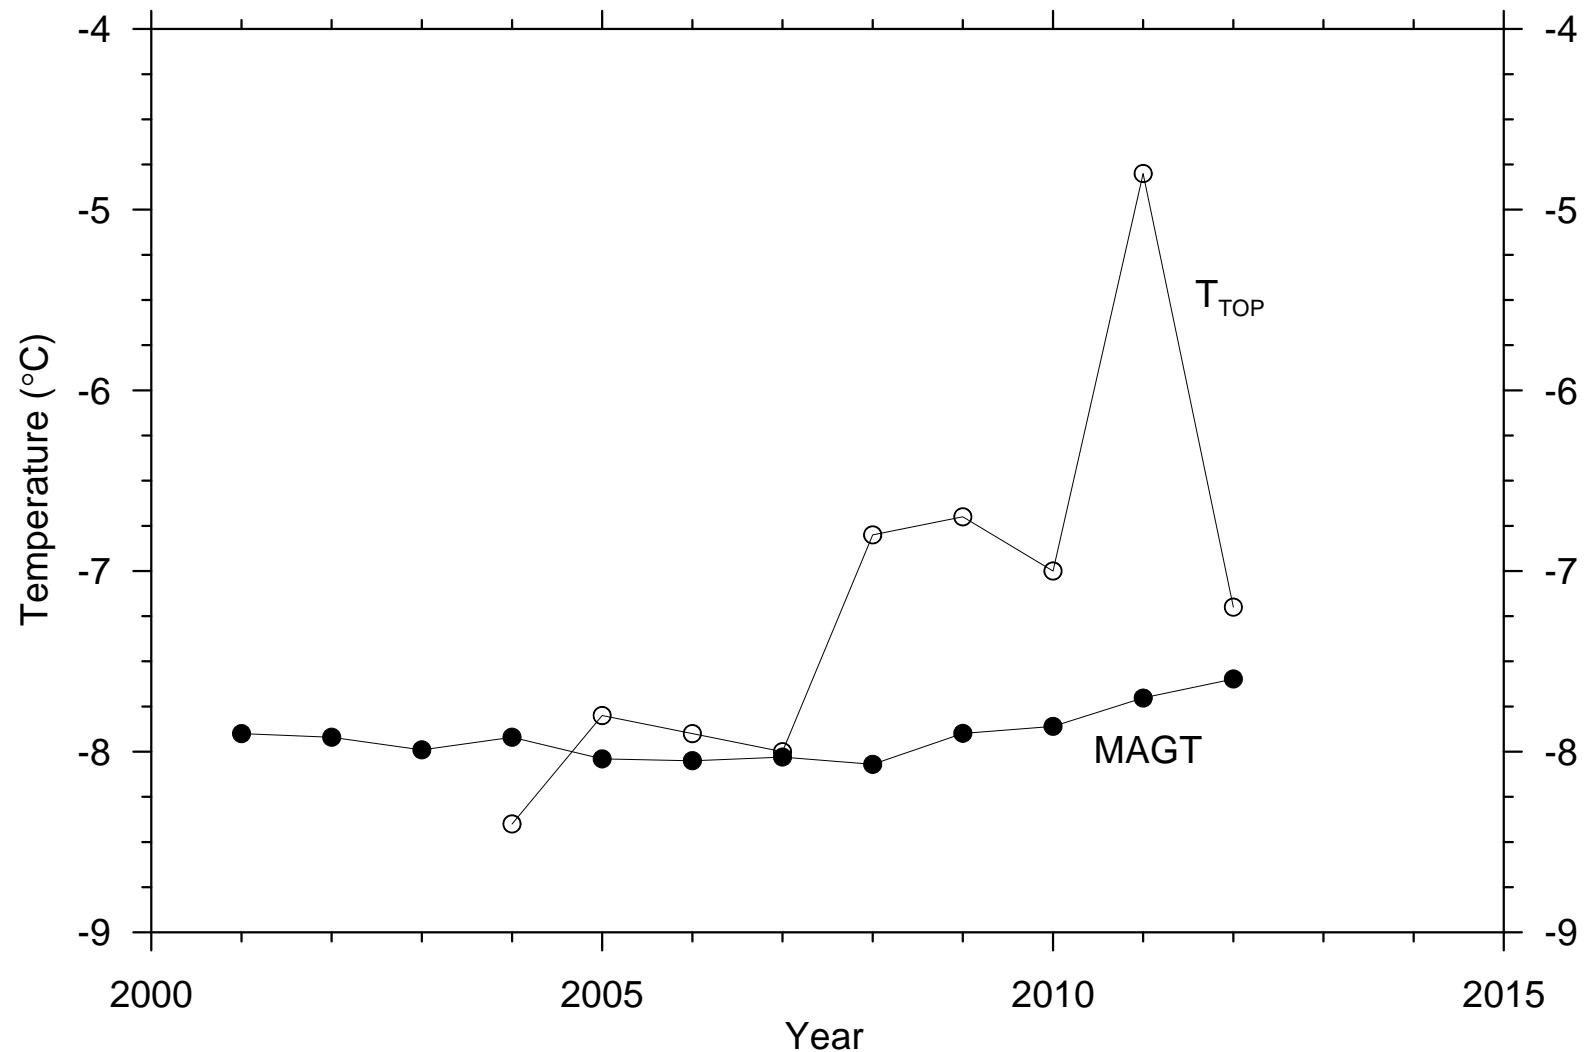
Permafrost at Collinson Head, 2001-2012

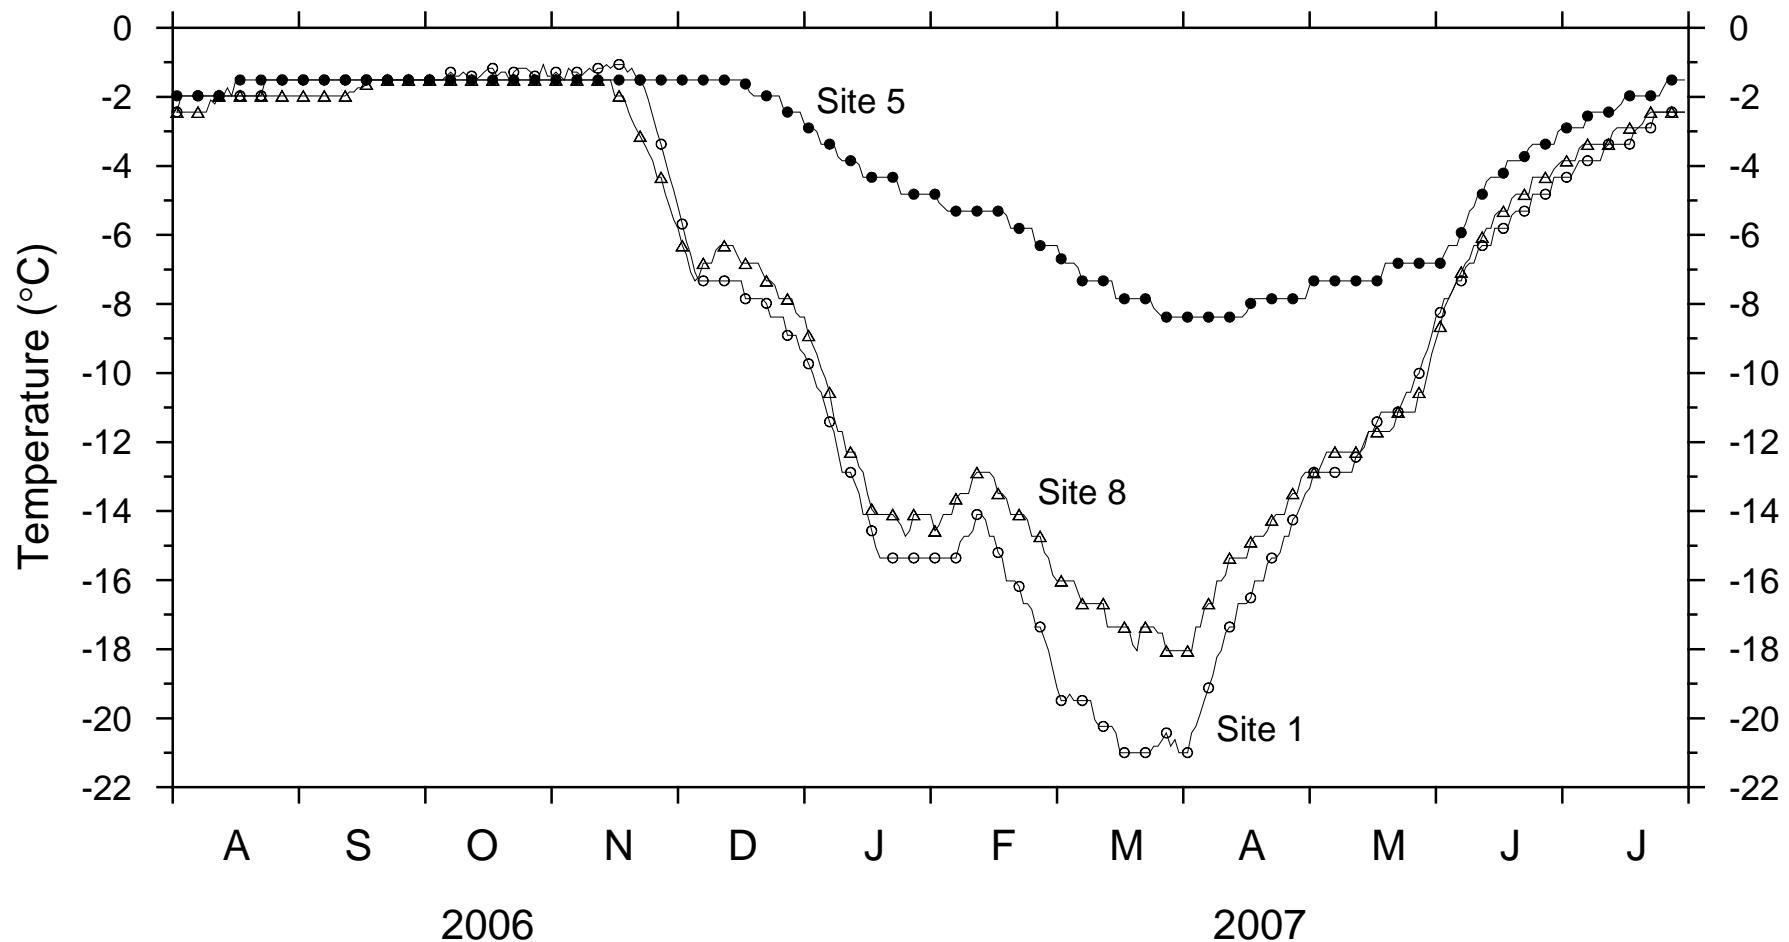
Ground temperatures and snow depth, 2006-2007
