Landscape and adaptation

Doug Esagok and Chris Burn

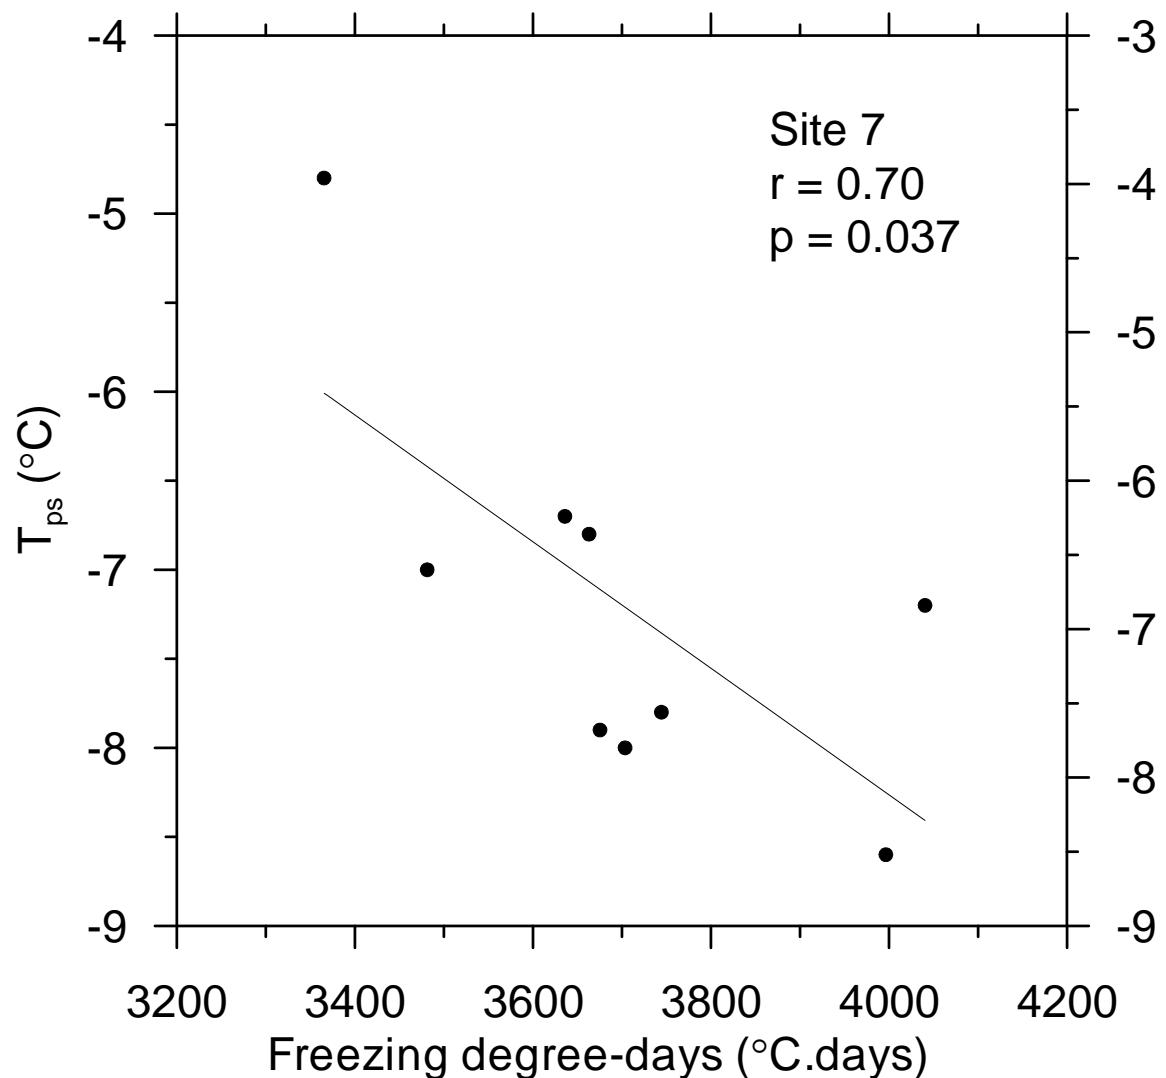
Freezing degree-days and T_{ps} , 2003-2012

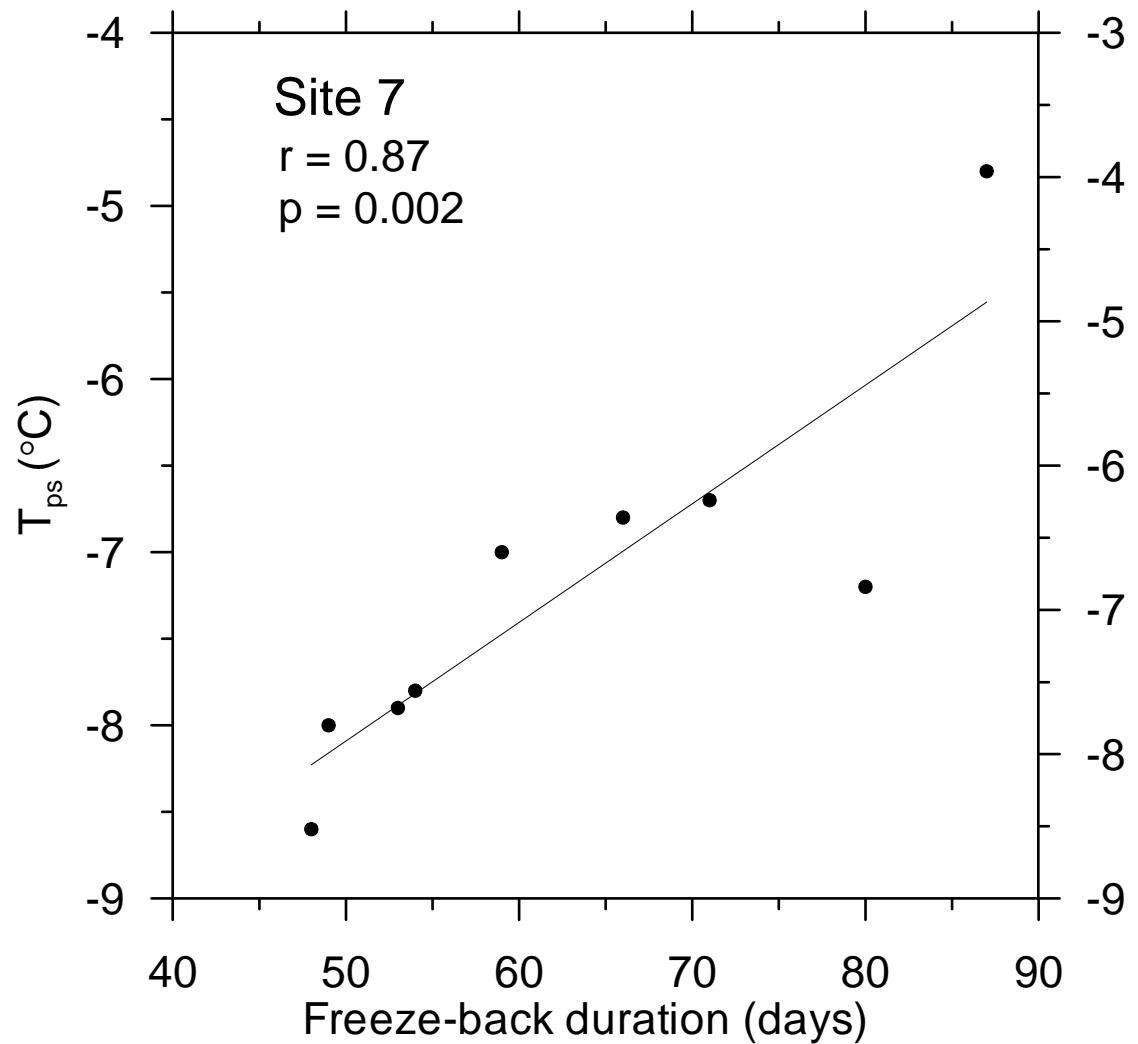
Freeze-back duration and T_{ps} , 2002-2012

Freeze-back duration and T_{ps} , 2003-2013

- Site 1 $n = 9, r = 0.92, p = 0.001$
- Site 3 $n = 8, r = 0.89, p = 0.003$
- Site 6 $n = 9, r = 0.85, p = 0.003$
- Site 7 $n = 9, r = 0.87, p = 0.002$
- Site 8 $n = 7, r = 0.88, p = 0.009$

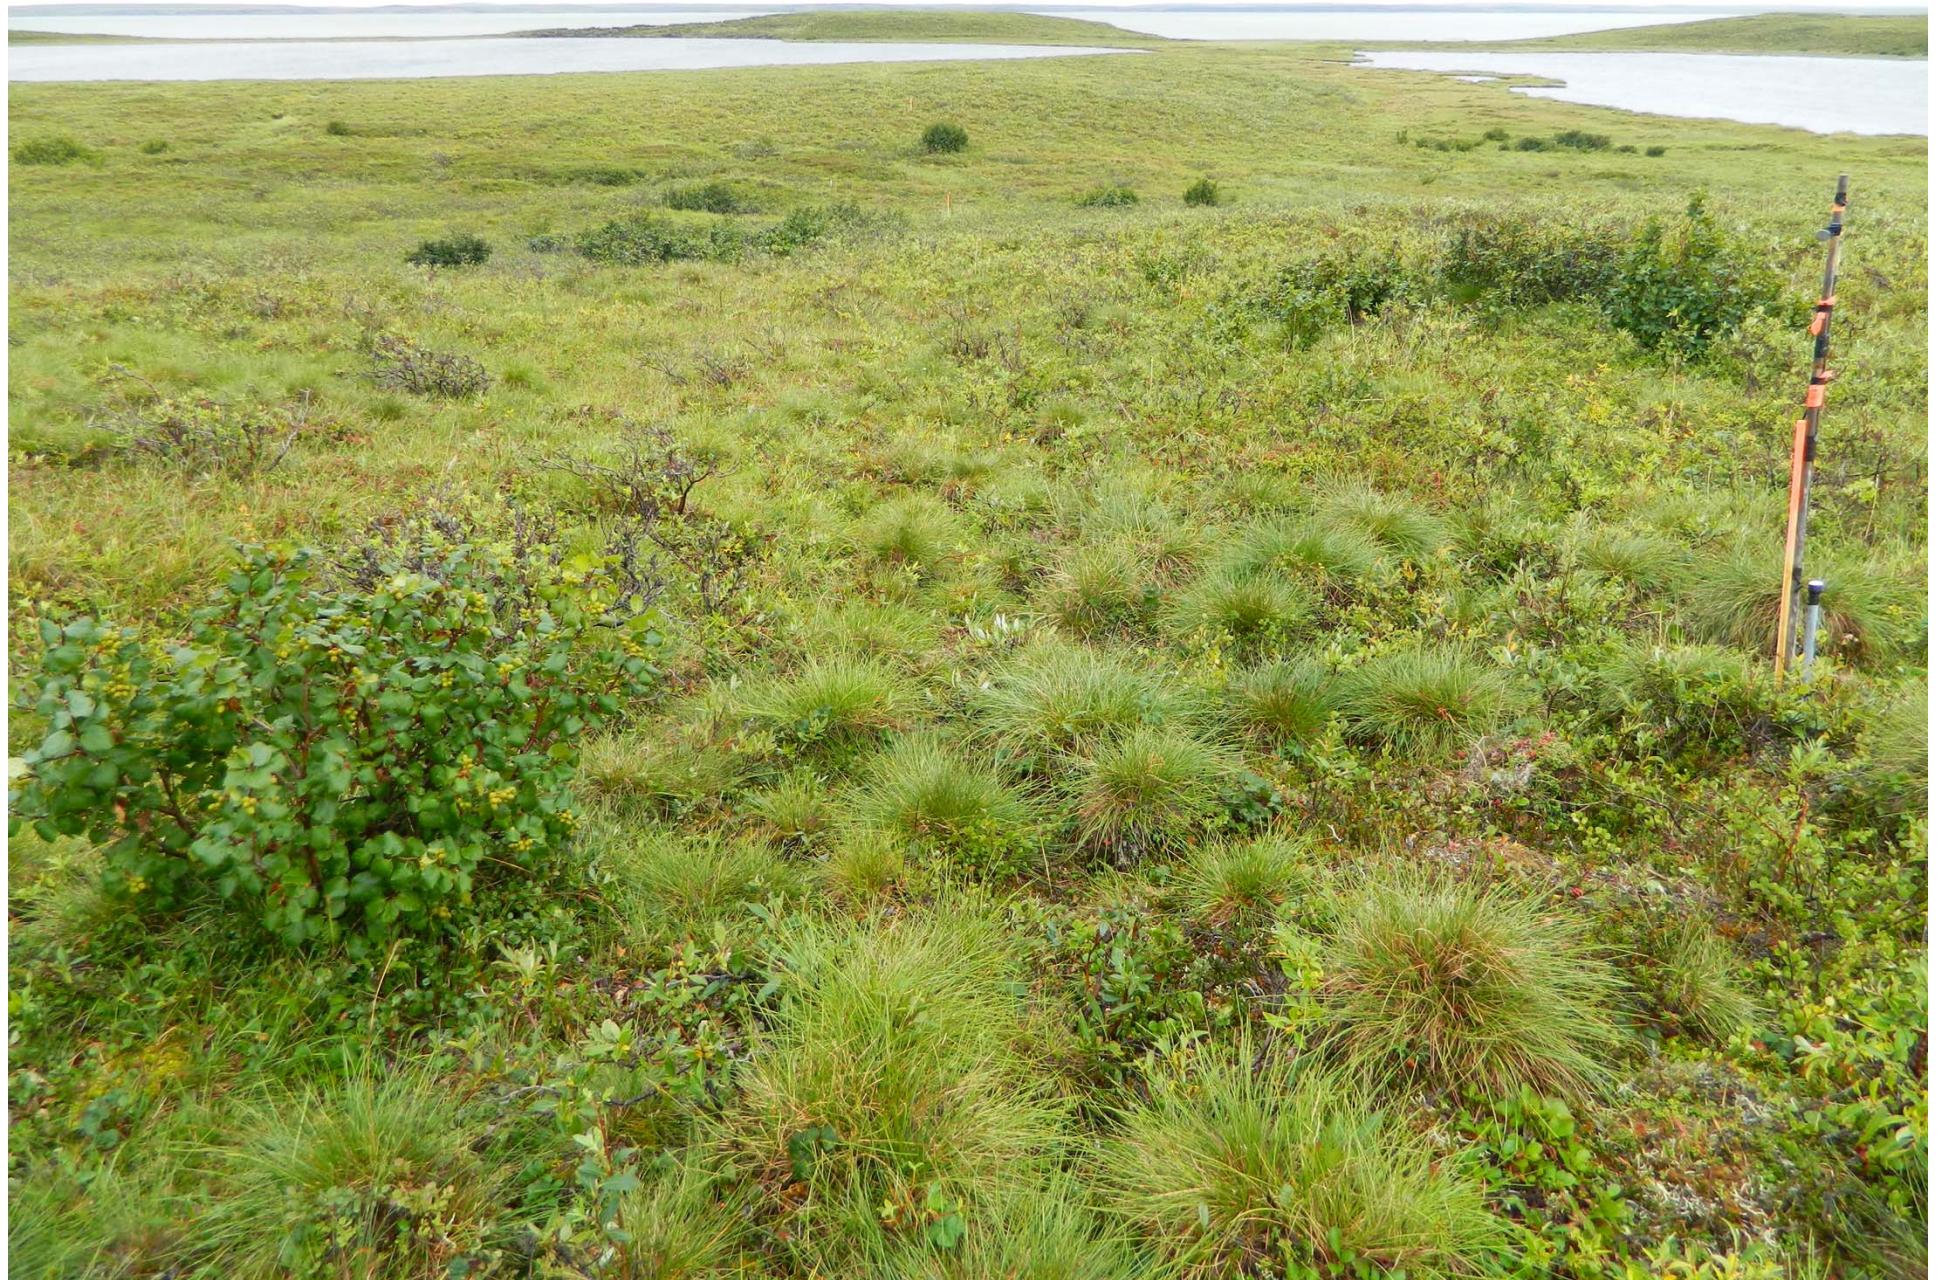
Irregular ground on hill slope

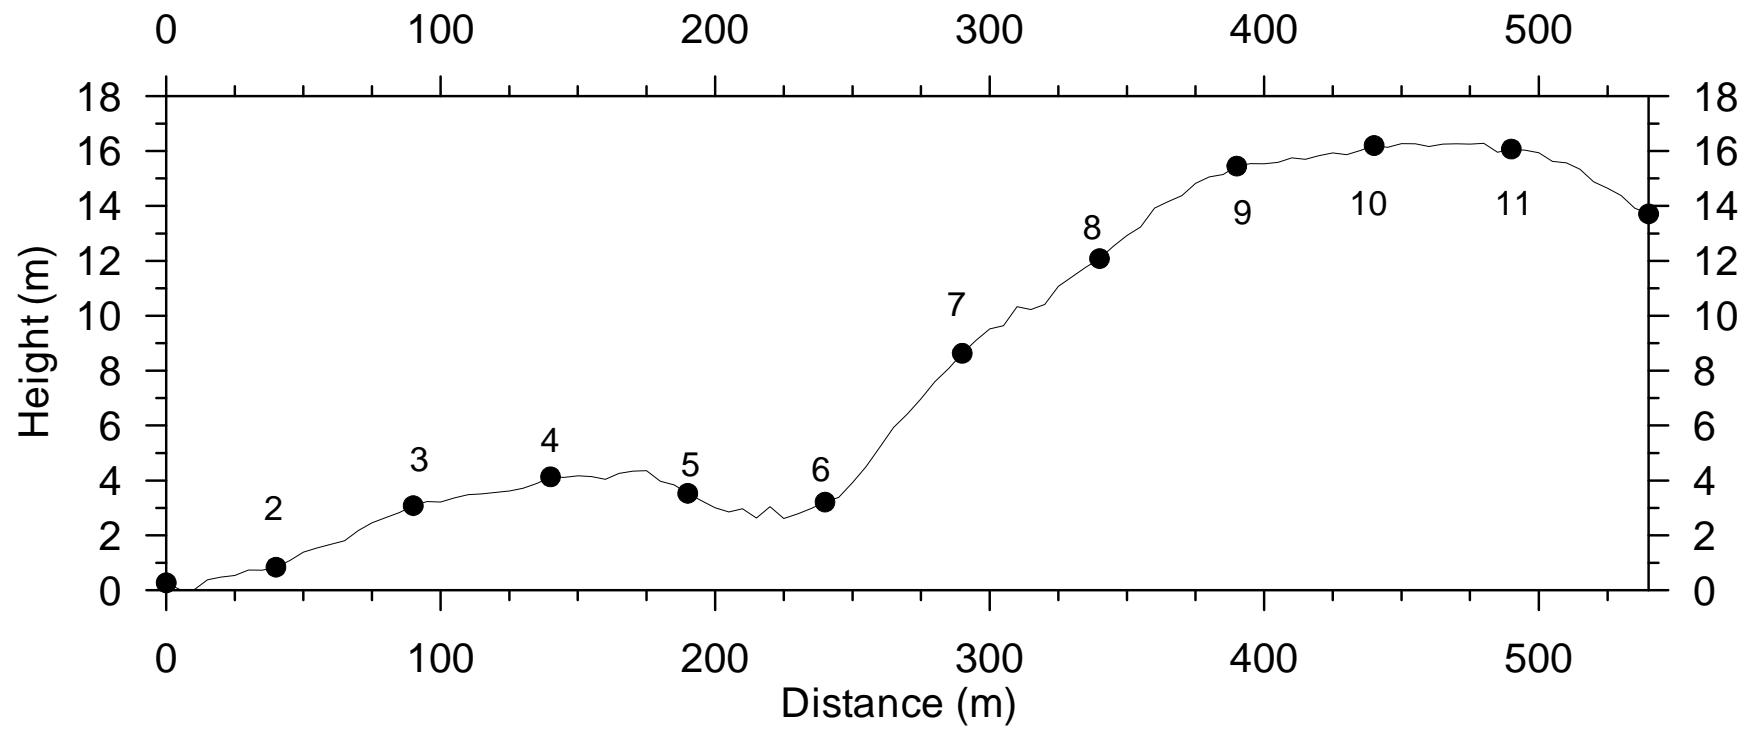
Topographic section

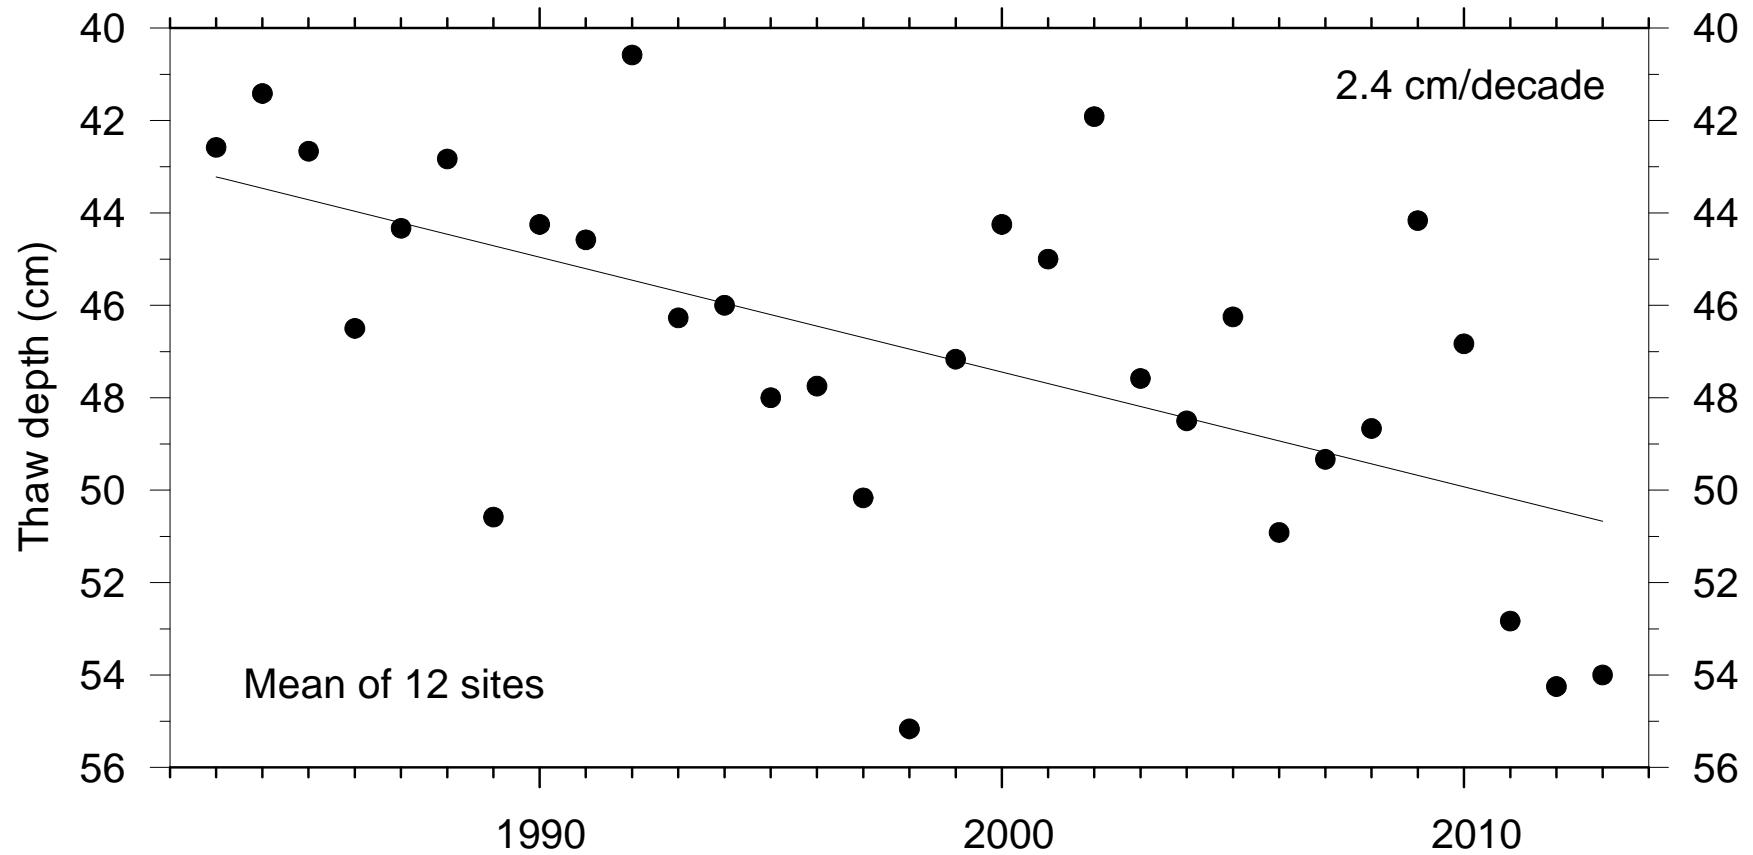
Late summer thaw depth, 1983-2013

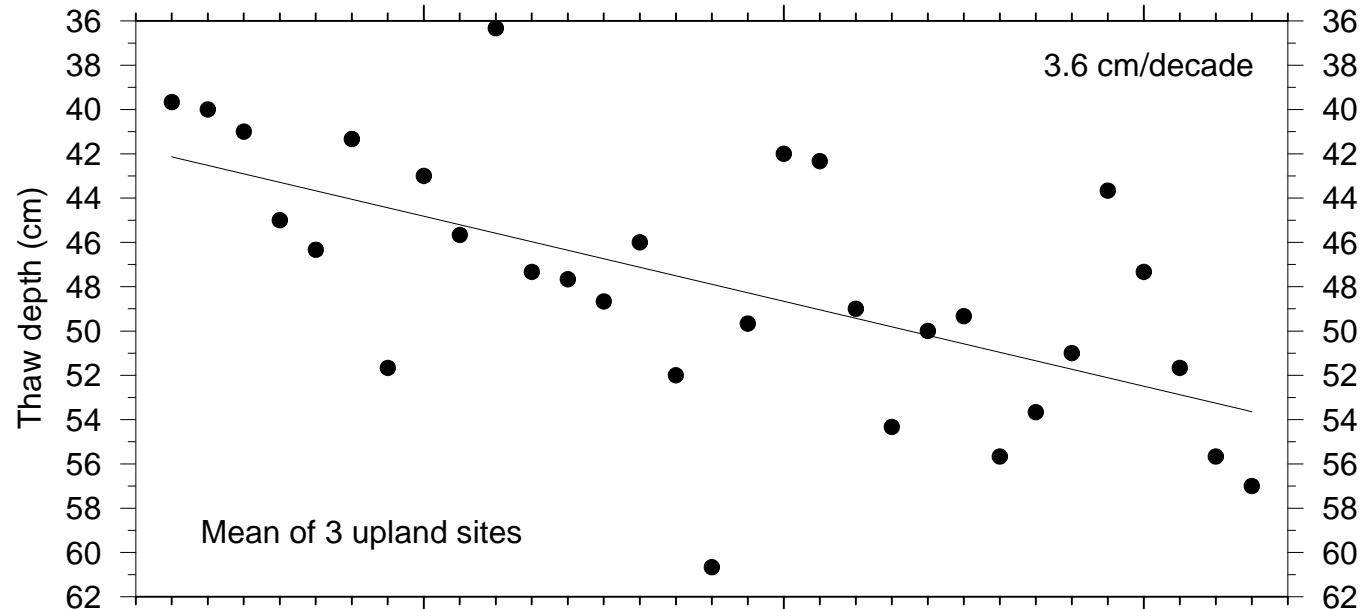
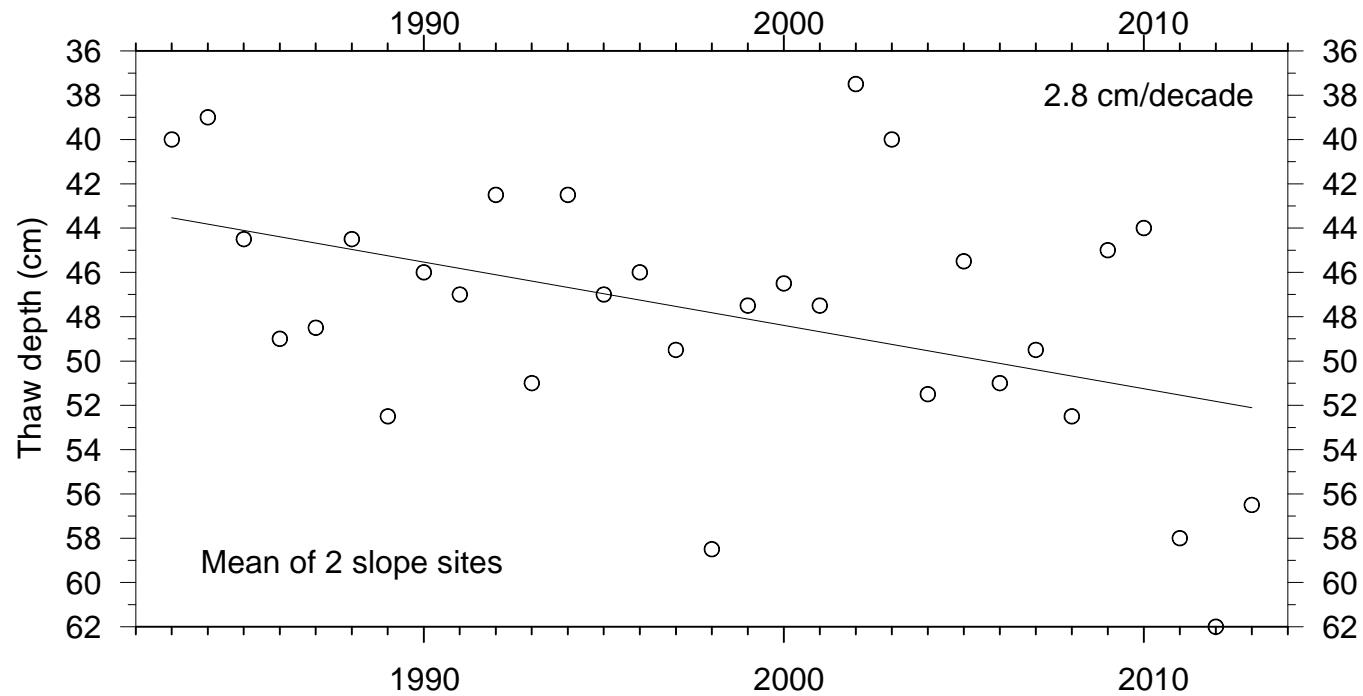
Seasonal effects and topography

Fall	Win	Spr	Sum	Yr
Upland	X	X	-	X	X
Slope	-	-	-	X	X
Lowland	X	-	-	-	X

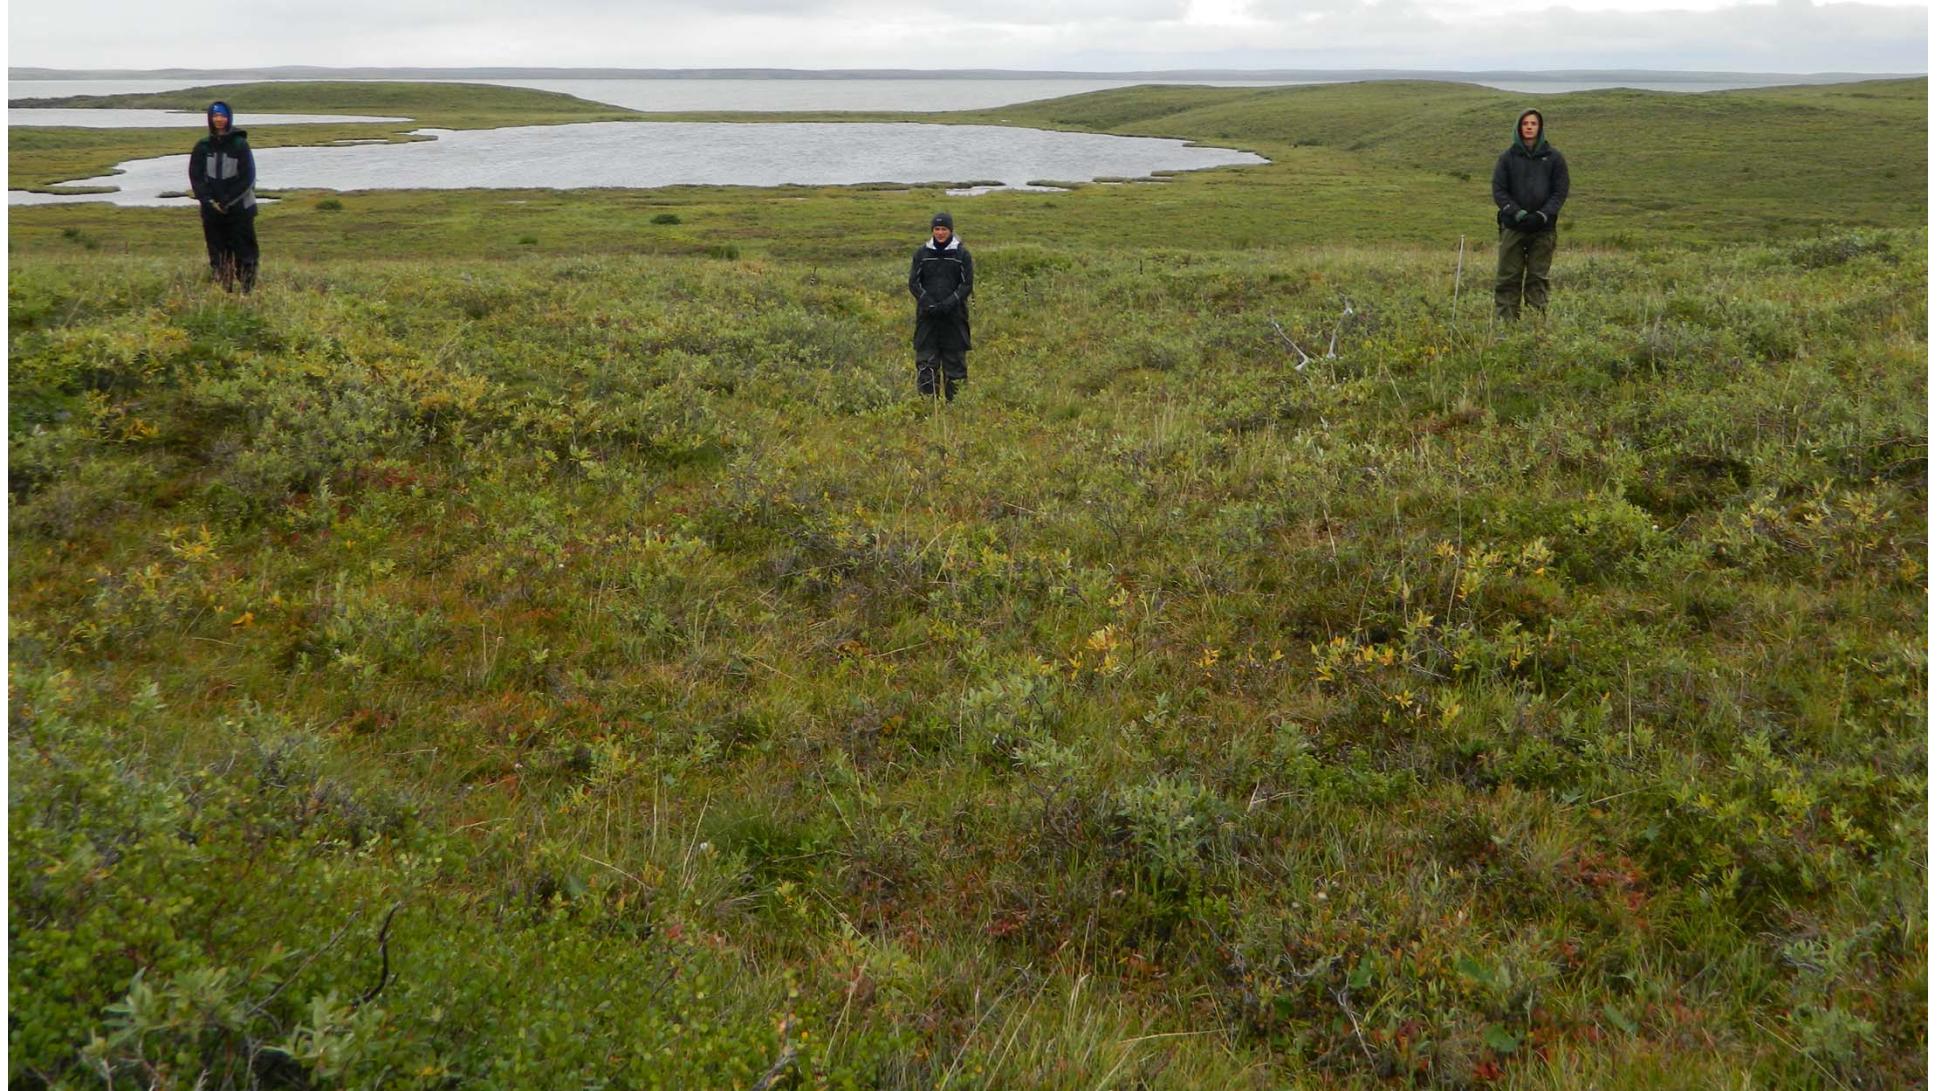
Hill slope ice-wedge trough

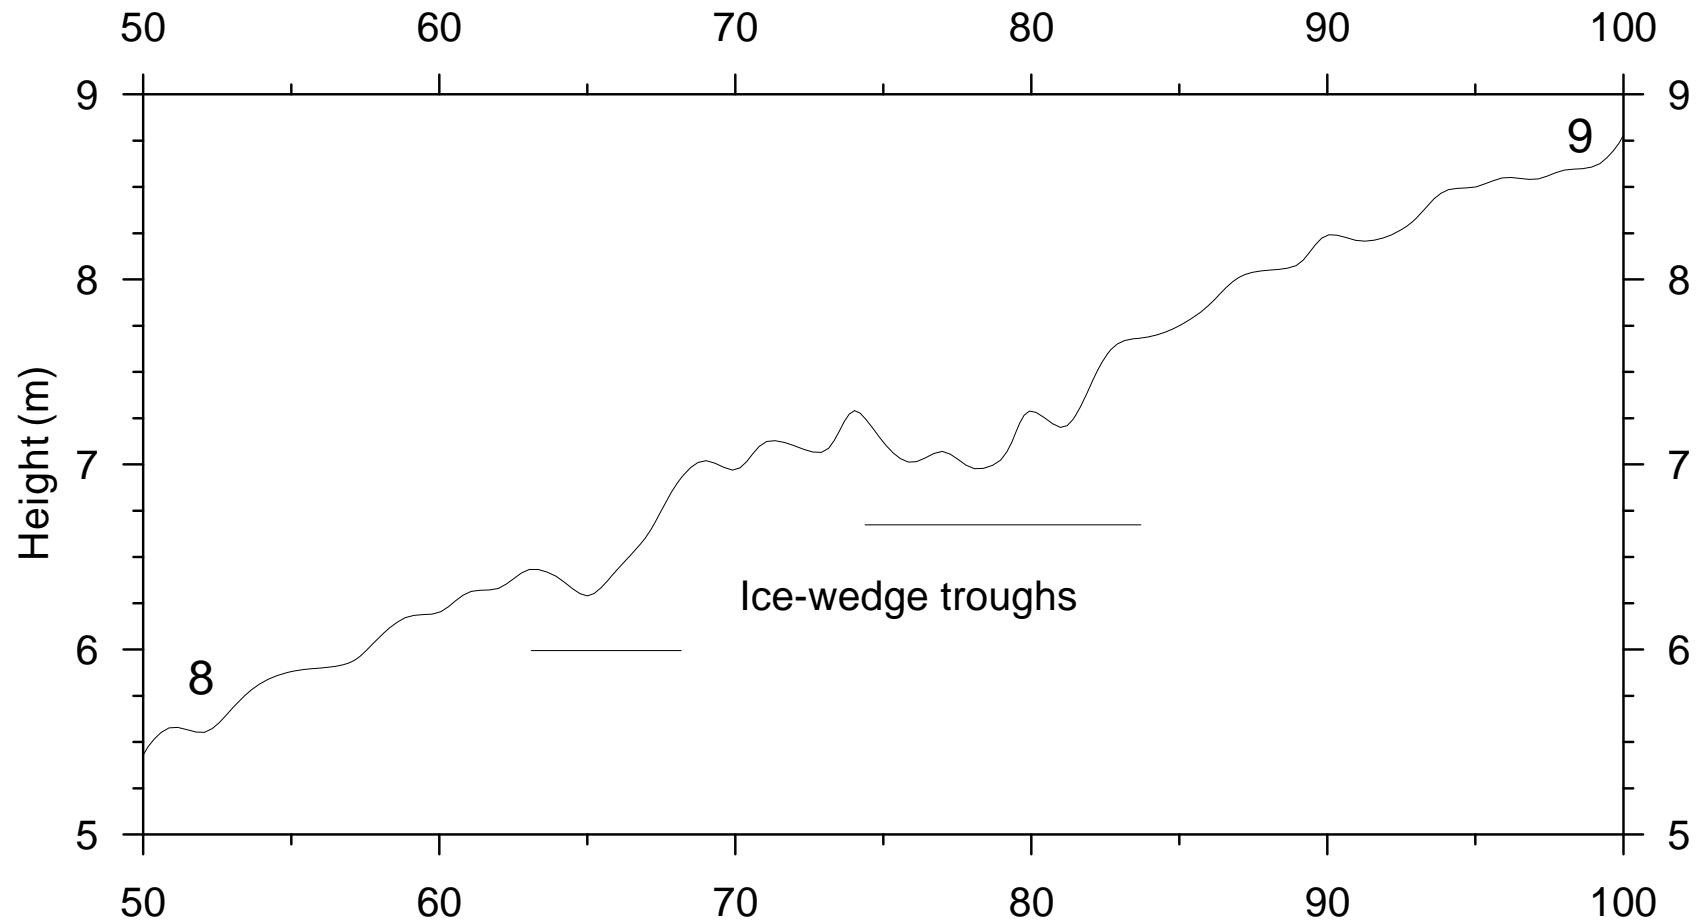
Subsidence at ice-wedge troughs

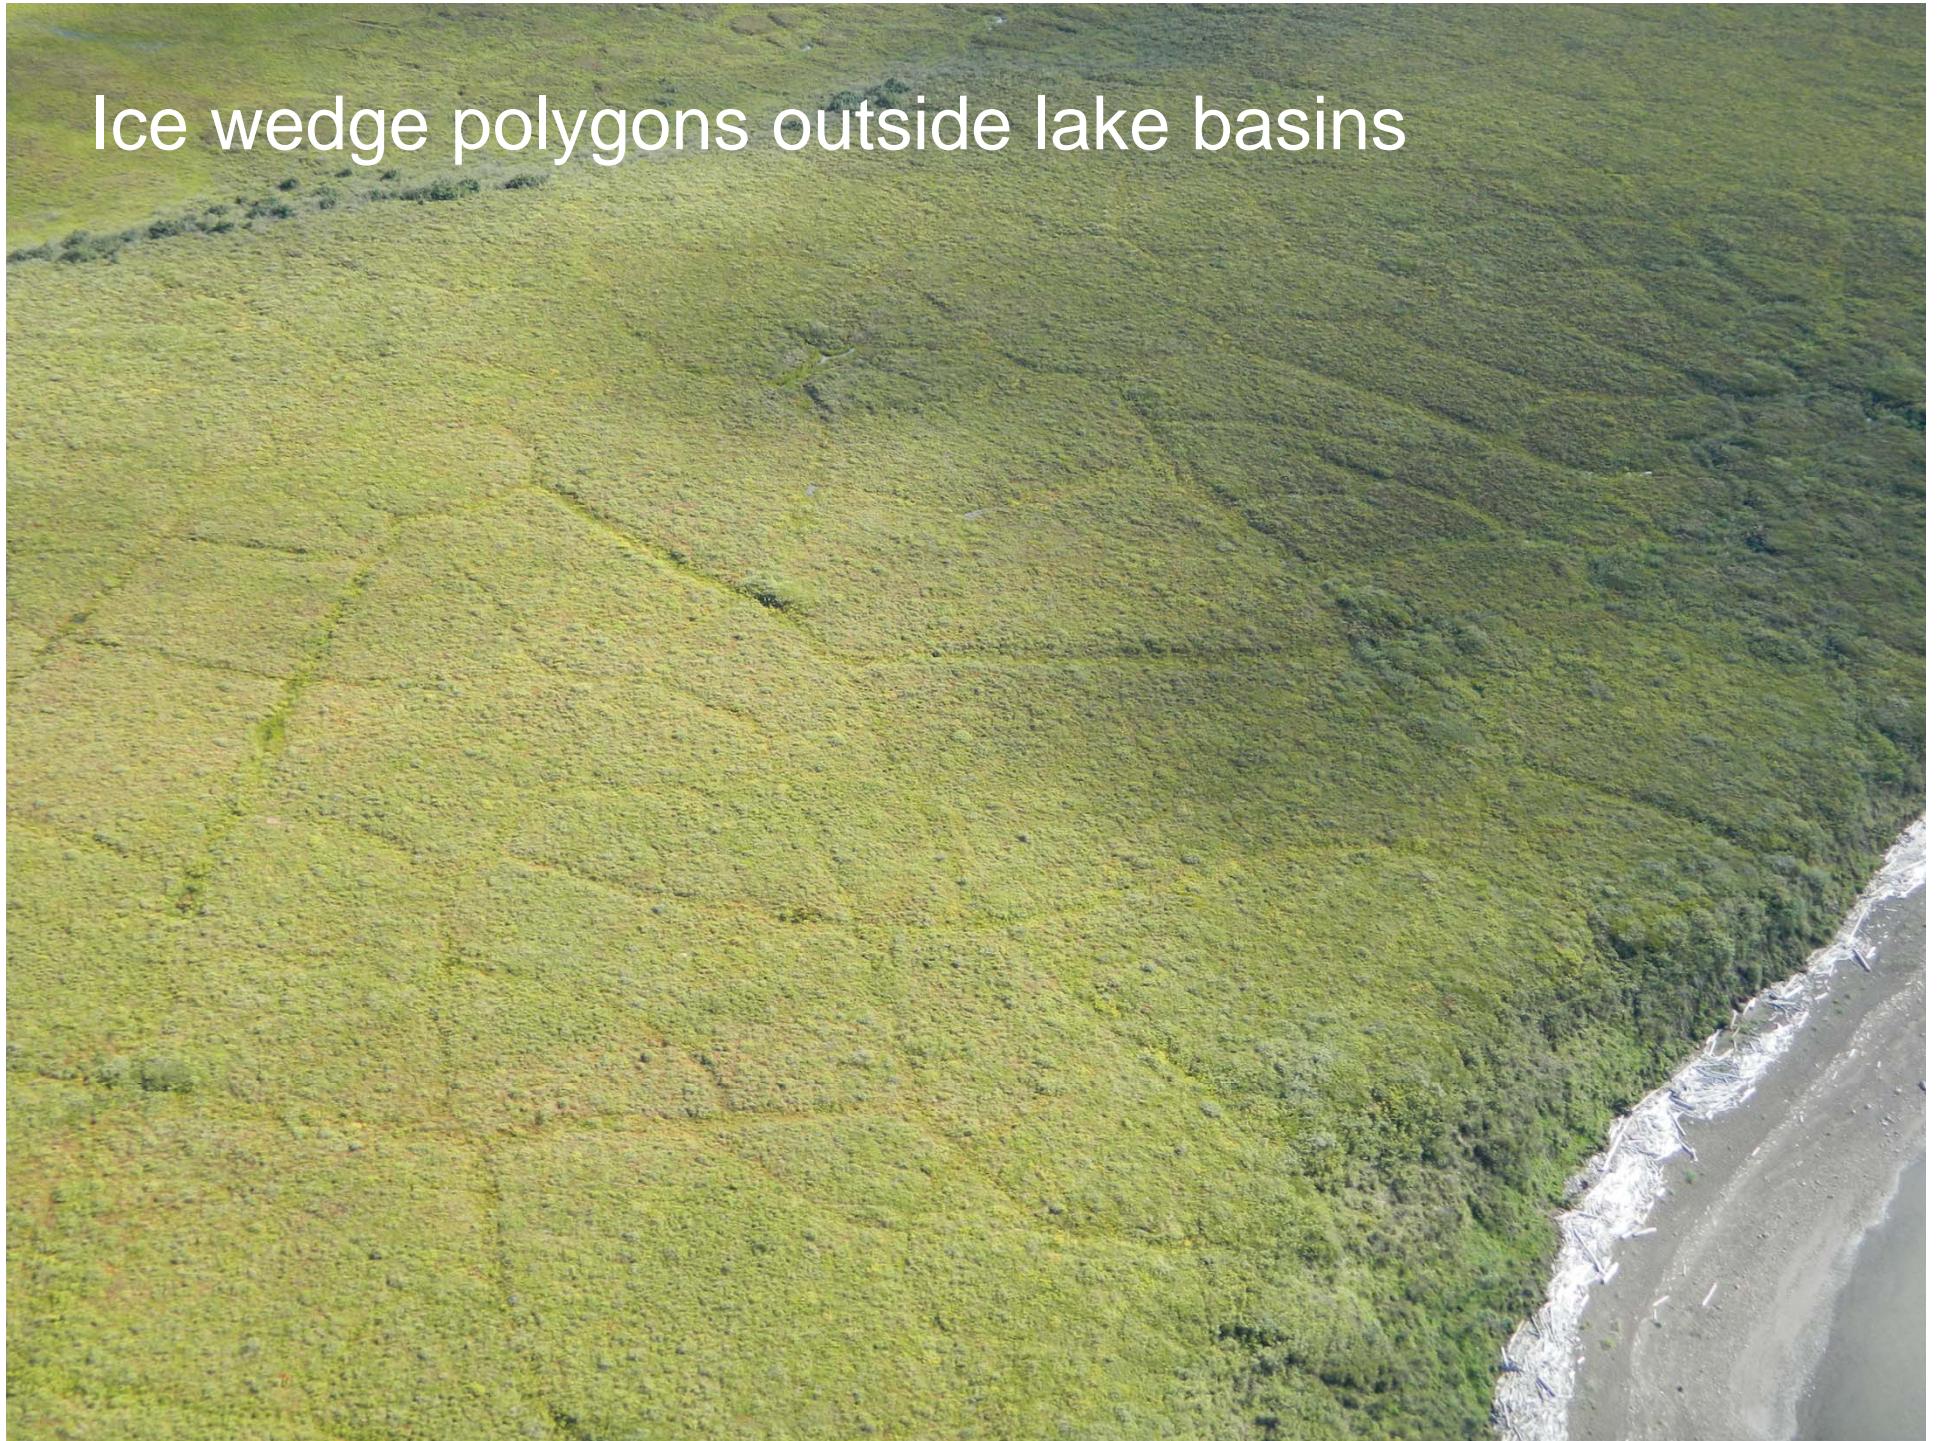
Ice wedge polygons outside lake basins
